**FINAL
HAZARDOUS MATERIALS SURVEY**

**STATE CORRECTIONAL INSTITUTION – PITTSBURGH
LAND USE FEASIBILITY STUDY
3001 BEAVER AVENUE
PITTSBURGH, PENNSYLVANIA 15233**

Project No. 2390

February 28, 2023

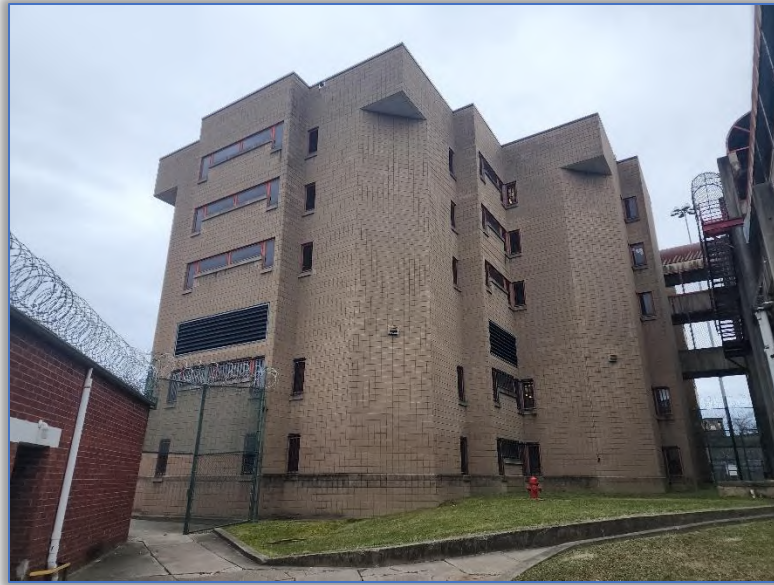
SCIP Building 5 – Housing Unit A. No ACM was detected in this building.

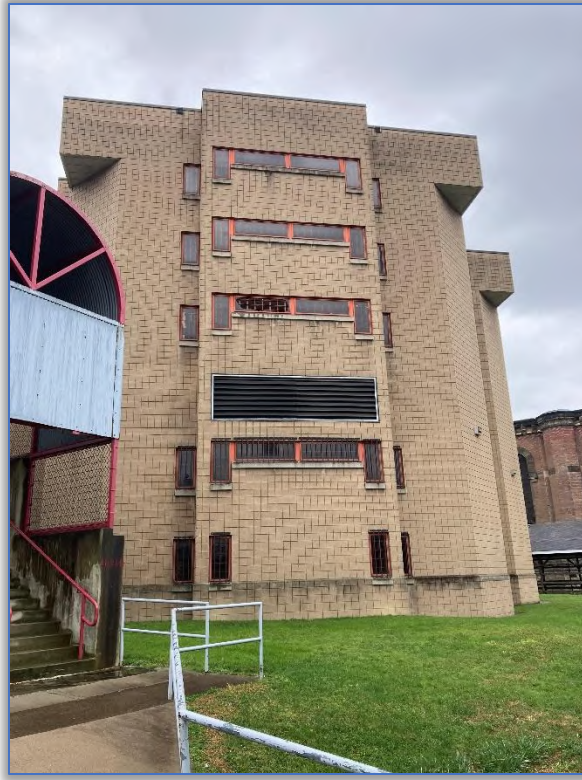
SCIP Building 6 – Housing Unit B. No ACM was detected in this building.

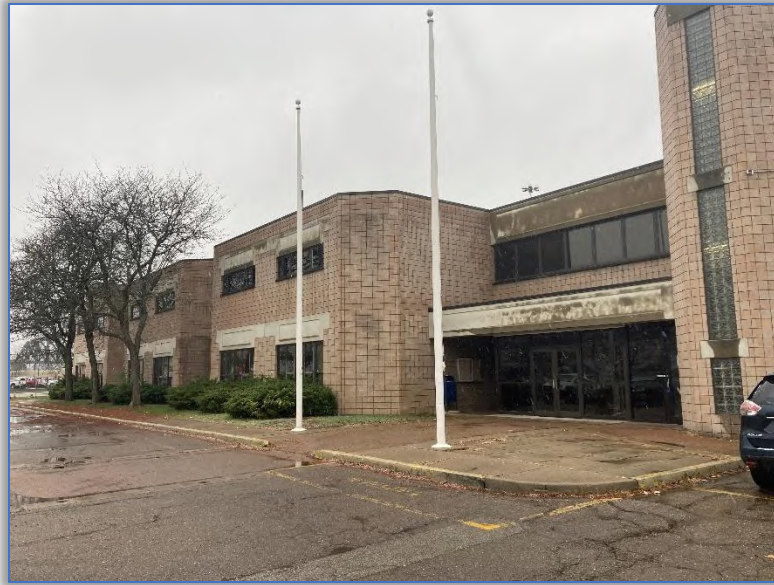
SCIP Building 7 – Administrative Complex. No ACM was detected in this building.

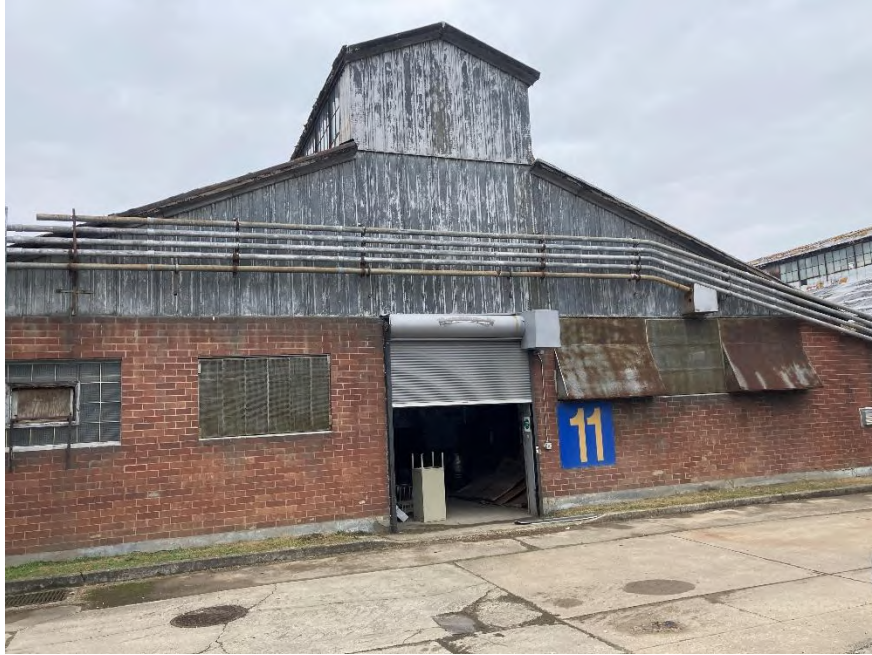
Photograph #1

SCIP Building 11 – Correctional Industries A.

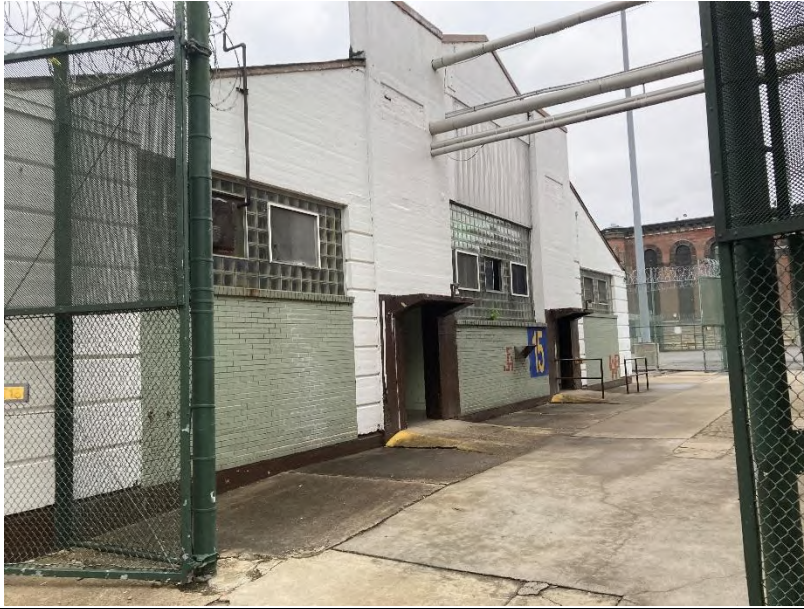
Photograph #1

SCIP Building 15 – Dining Hall.

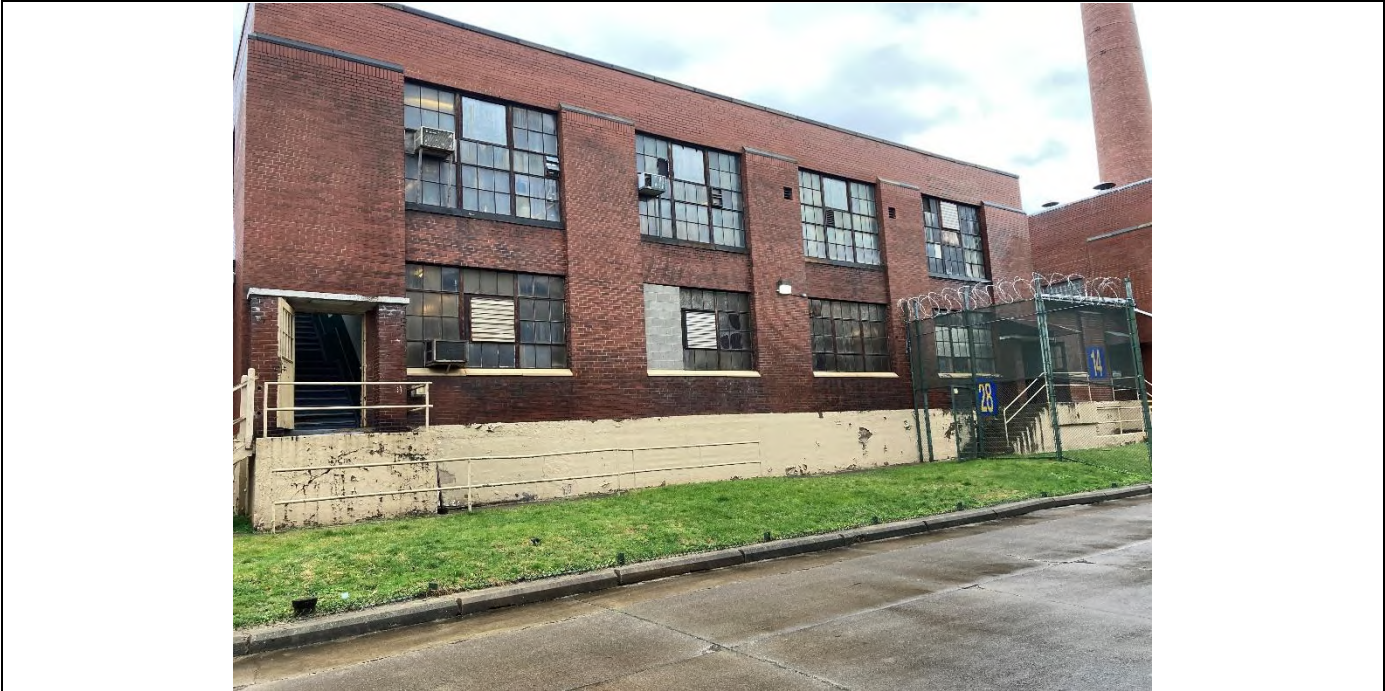
Photograph #1	SCIP Building 28 – Maintenance Shops. No ACM was detected in this building.
----------------------	---

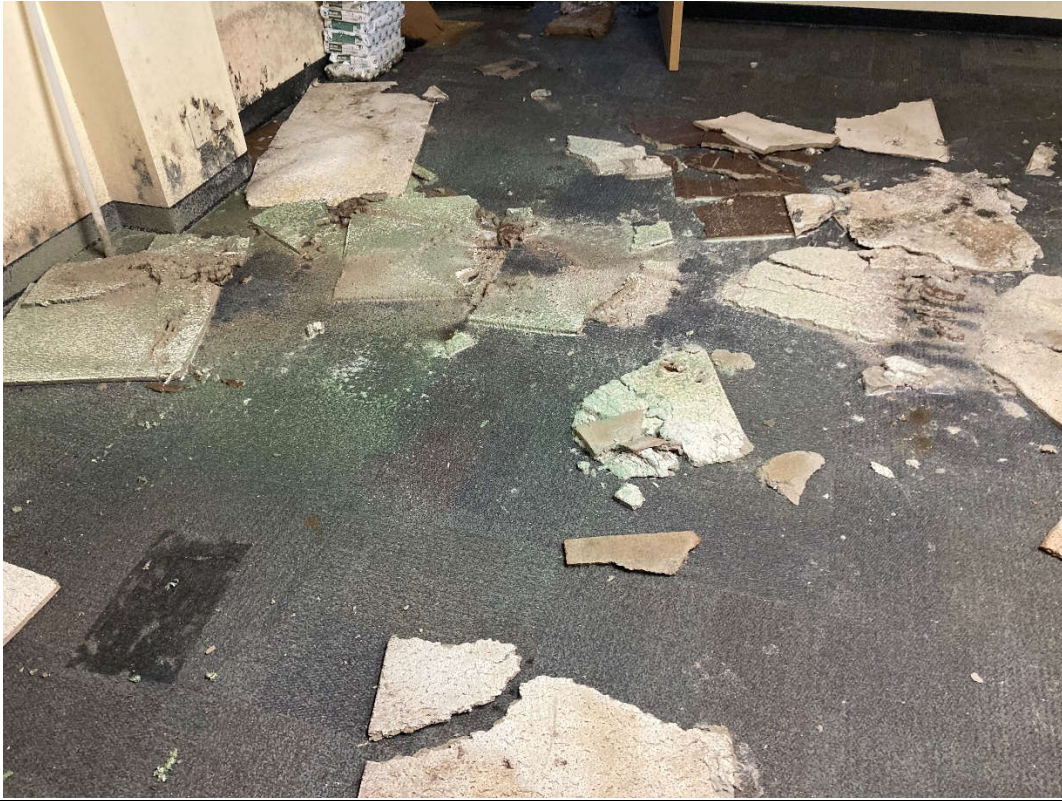
Photograph #1

- + Water damage and/or mold problems were observed within all structures located at the subject property. It should be noted that the potential for mold is present in each building, primarily related to the deterioration of roofing material causing water damage, which leads to mold.

Example of mold found throughout all buildings due to water damage.

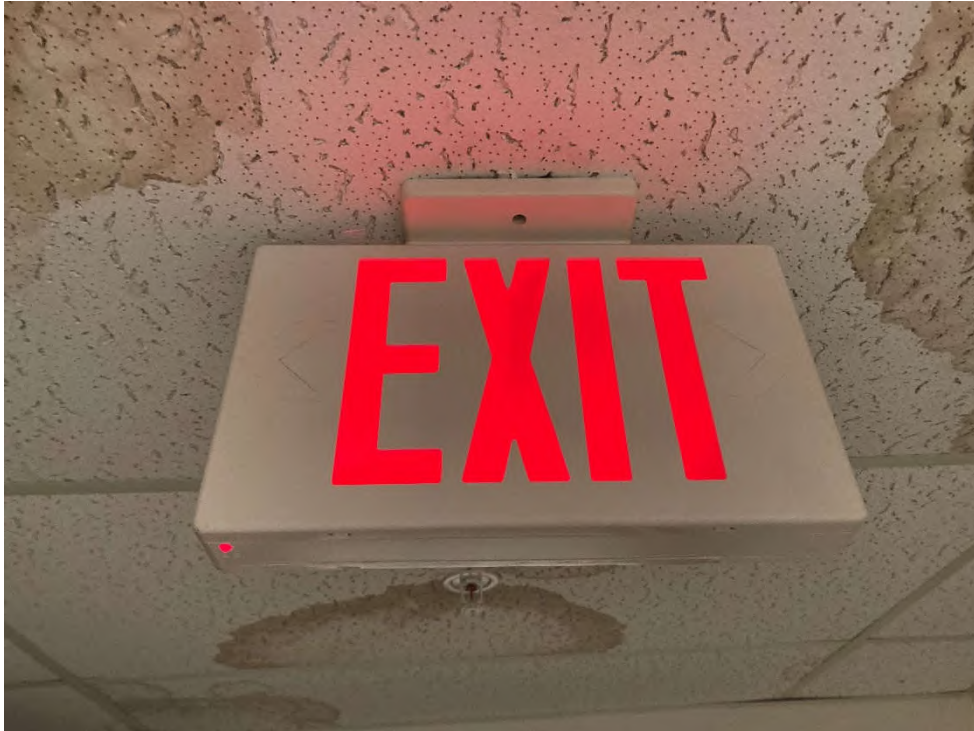
Photograph #3

- + Approximately 123 Exit signs were noted during inspection. Self-luminous Exit signs containing the radioactive gas, tritium, were historically used in a variety of facilities across the United States. Intact tritium Exit signs pose little or no threat to public health and safety and do not constitute a security risk. However, the Nuclear Regulatory Commission (NRC) requires proper accounting and disposal of all radioactive materials. Proper handling and accounting are important, because a damaged or broken sign could cause minor radioactive contamination of the immediate vicinity, requiring a potentially expensive clean up. It is recommended that all Exit signs be collected intact and disposed of at a licensed recycling facility.

Example of exit signs found in many of the buildings on site
