BULLETIN NO. 1
on

PROJECT NO. DGS 974-9 PHASE 1
RESTORATION AND REFIT
US BRIG NIAGARA

16 May 2015

Lead Paint Survey for "Brig Niagara"

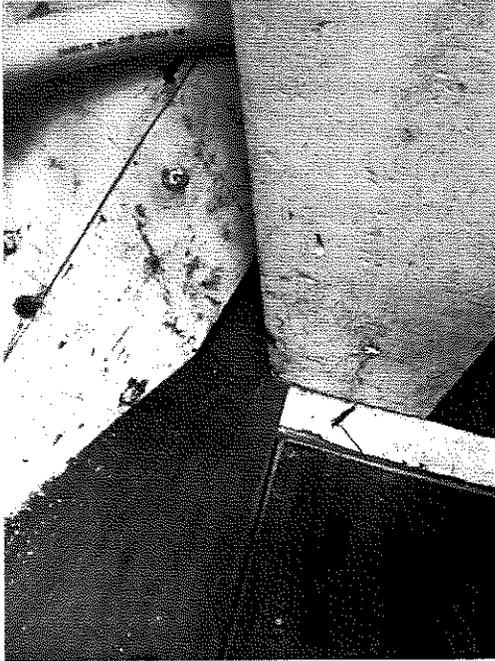
1) Forepeak, futtock, port side near samson post

Orange paint tested positive for lead

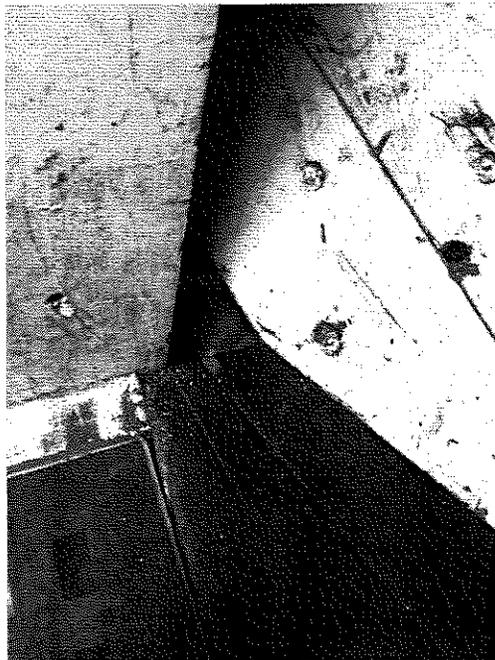
2) Forepeak futtock, starboard side near samson post

Orange paint tested positive for lead

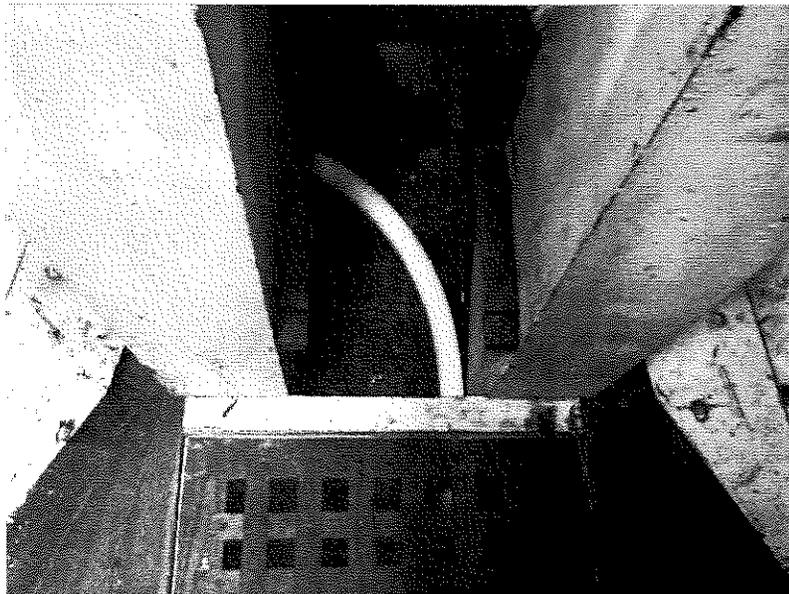
3) Forepeak, stem, near samson post

Orange paint tested positive for lead

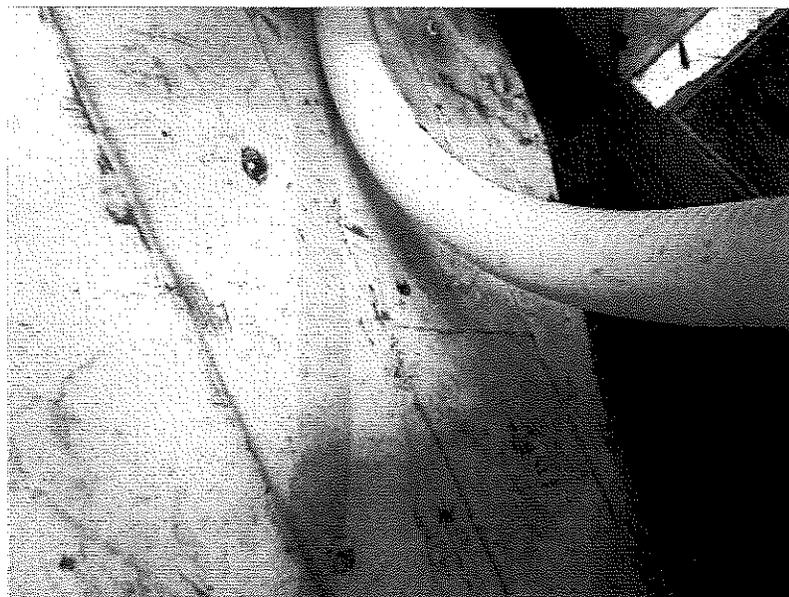
4) Forepeak, ceiling planking, port side

White paint scraped back to reveal orange primer. Tested positive for lead

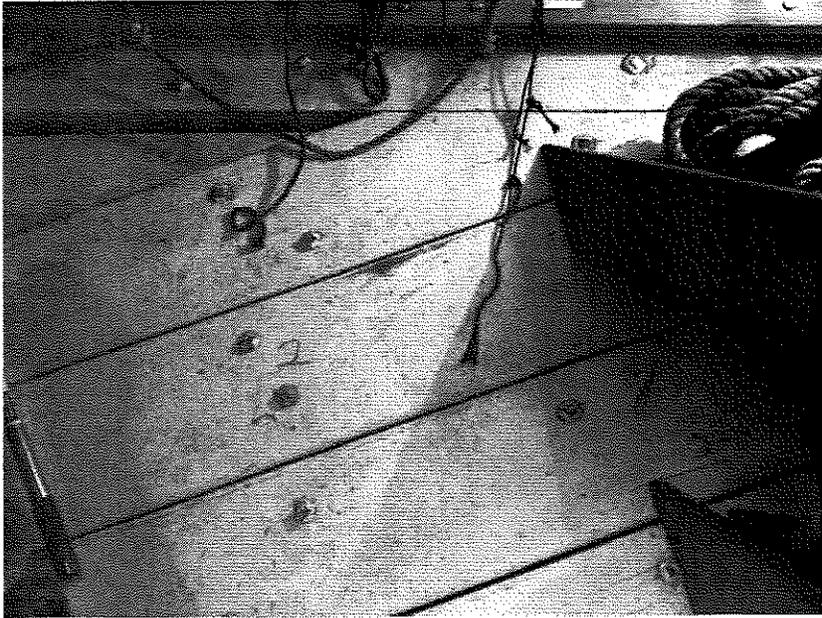
5) Forepeak, bilge stringer, port side

White paint scraped back to reveal orange primer. Tested positive for lead

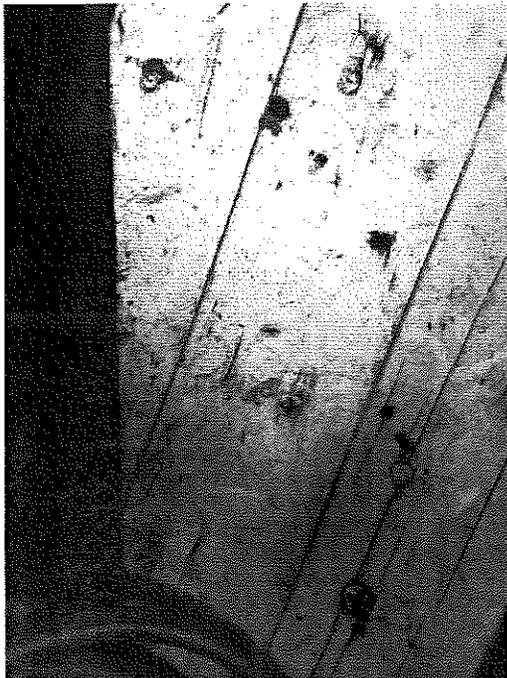
6) Forepeak, ceiling planking, starboard side

Chipped white paint revealed orange paint underneath. Tested positive for lead

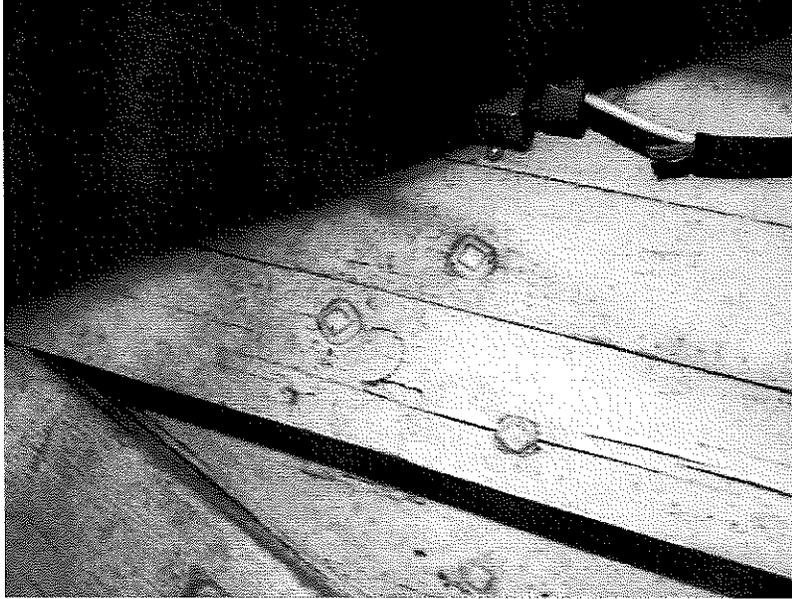
7) Forepeak, sheer clamp, starboard side

Chipped white paint revealed orange paint underneath. Tested positive for lead

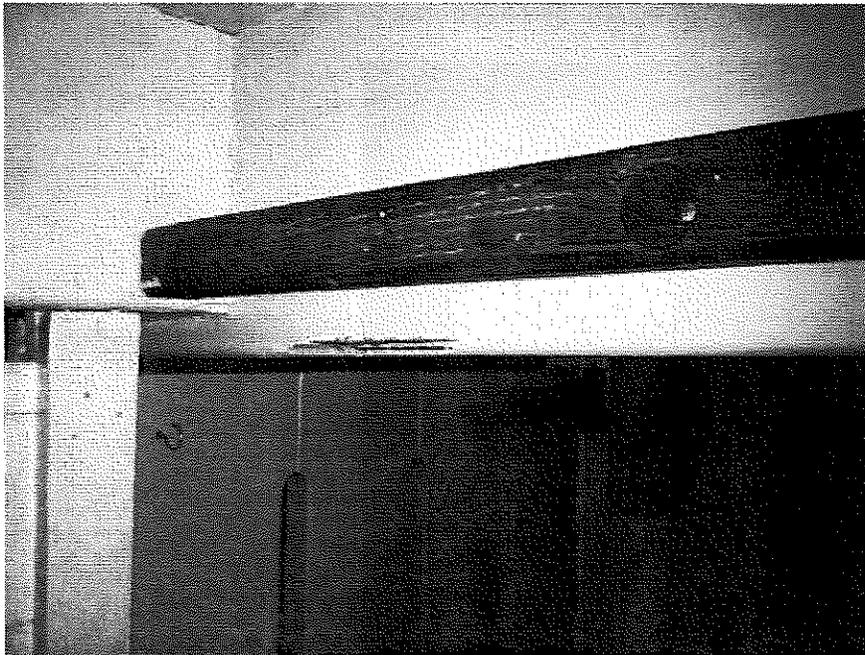
8) Galley, deck beam, port side aft

White paint scraped back, no signs of orange paint. Tested negative for lead

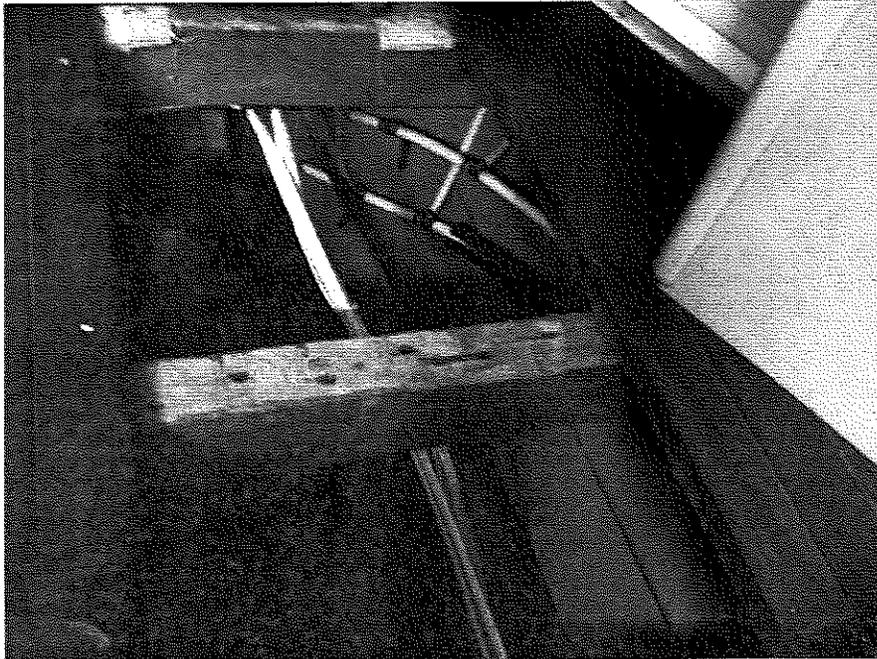
9) Galley, sole beam, starboard side

Exposed orange paint tested positive for lead

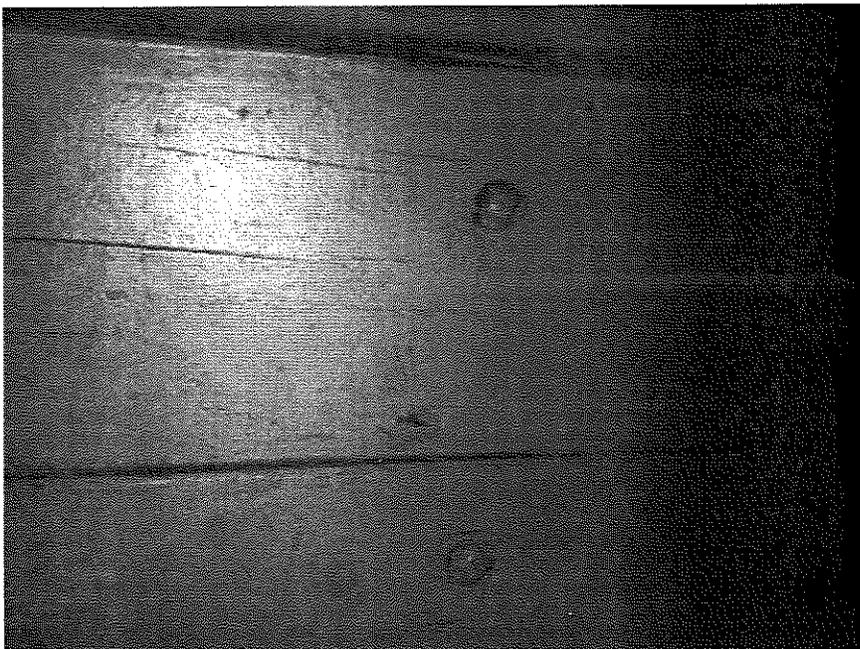
10) Galley, ceiling planking, starboard side

Chipped grey paint revealed orange paint underneath. Tested positive for lead

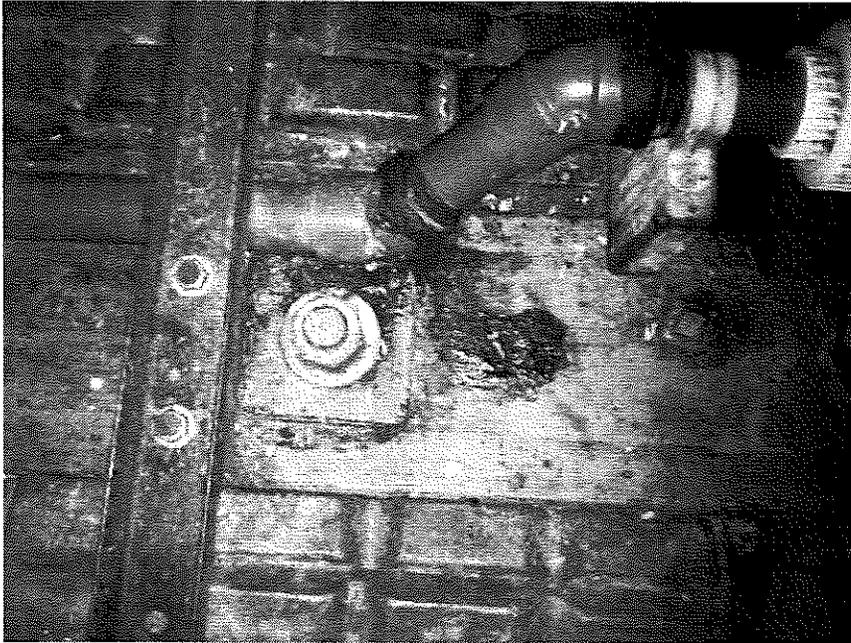
11) Birth Deck, keel, forward

Exposed orange paint tested positive for lead

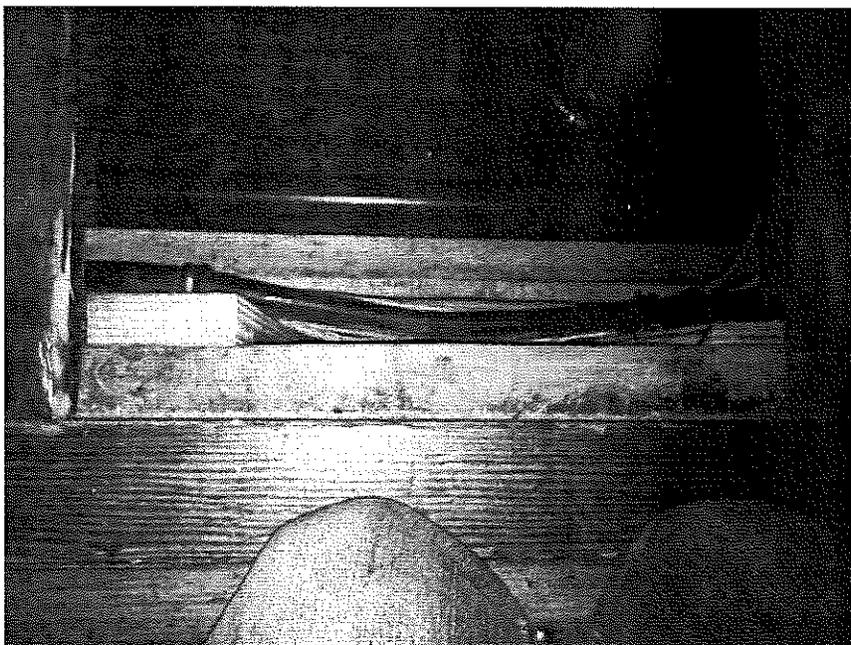
12) Birth deck, sole beam, amidships

Exposed orange paint tested positive for lead

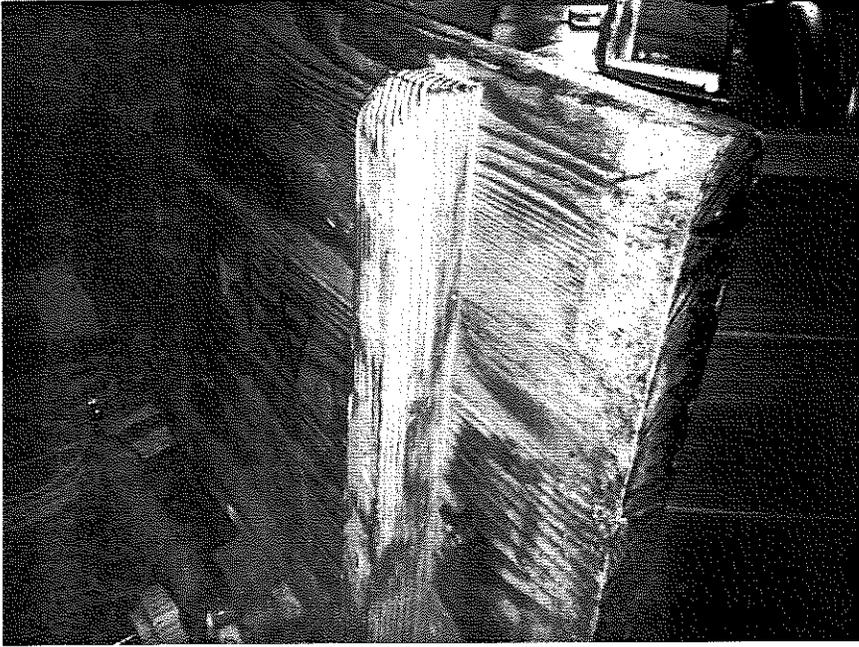
13) Birth deck, sole board, amidships

Exposed orange paint tested positive for lead

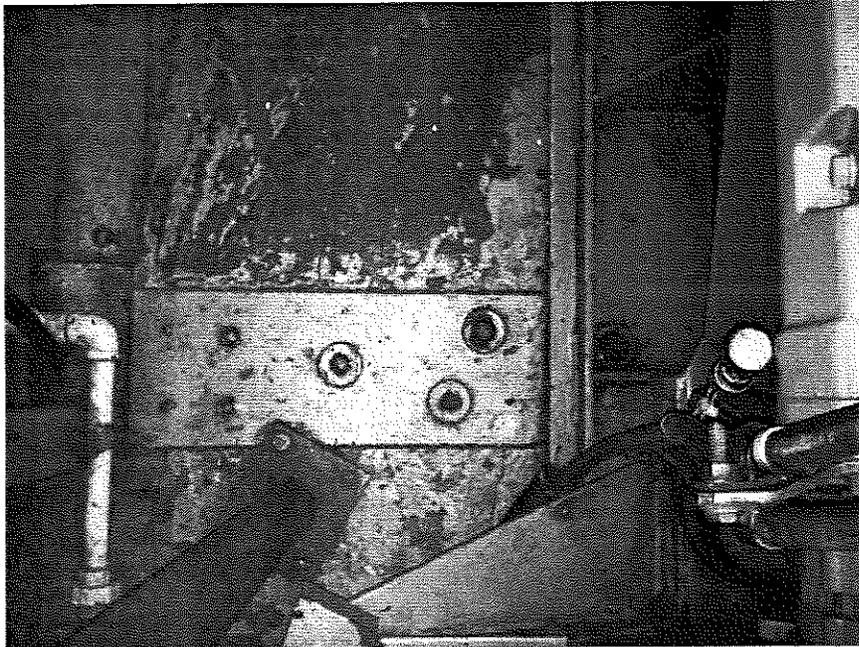
14) Engine Room, engine bed starboard side

Chipped grey paint revealed orange paint underneath. Tested positive for lead

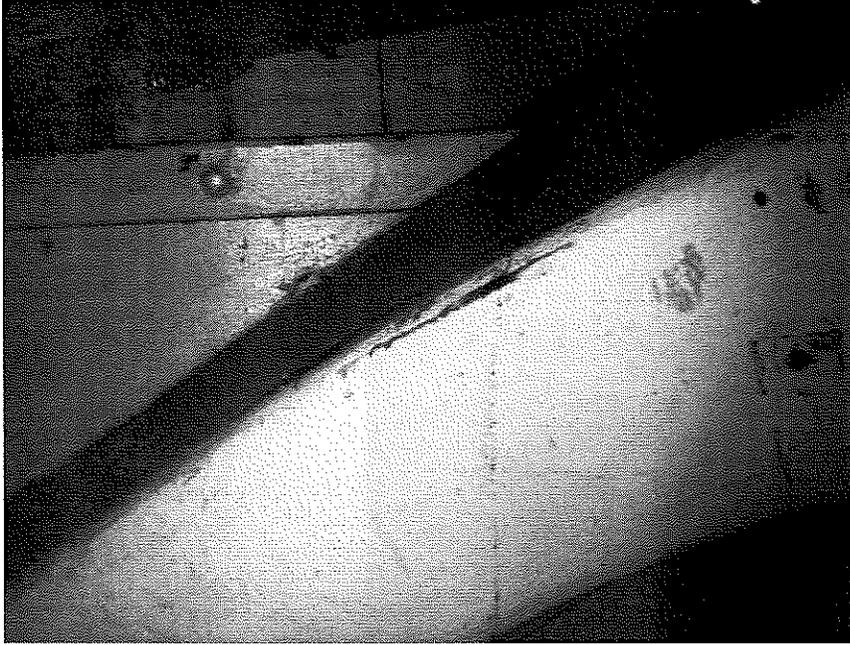
15) Engine room, diagonal hanging knee, starboard side

White paint scraped back to reveal orange primer. Tested positive for lead

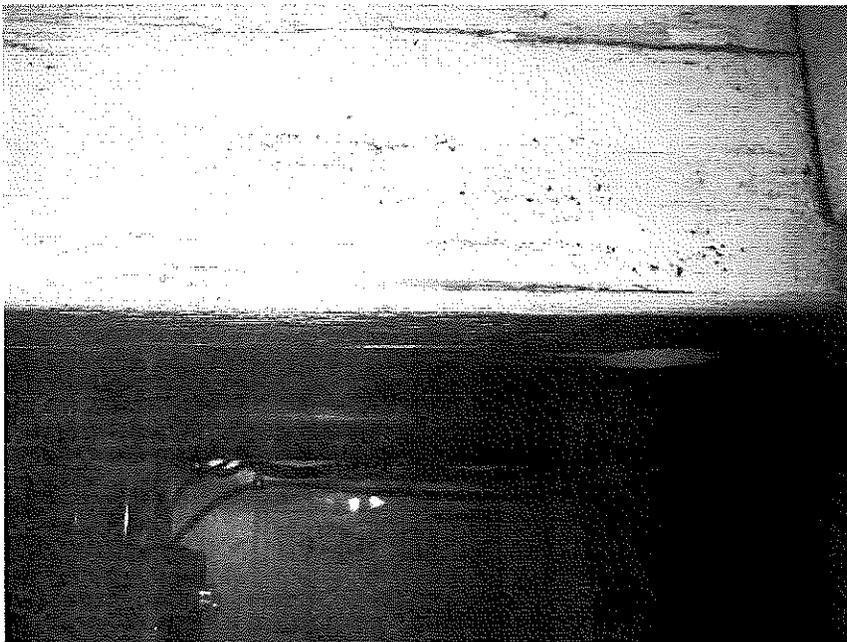
16) Engine room, deck beam, port side aft

White paint scraped back to reveal orange primer. Tested negative for lead

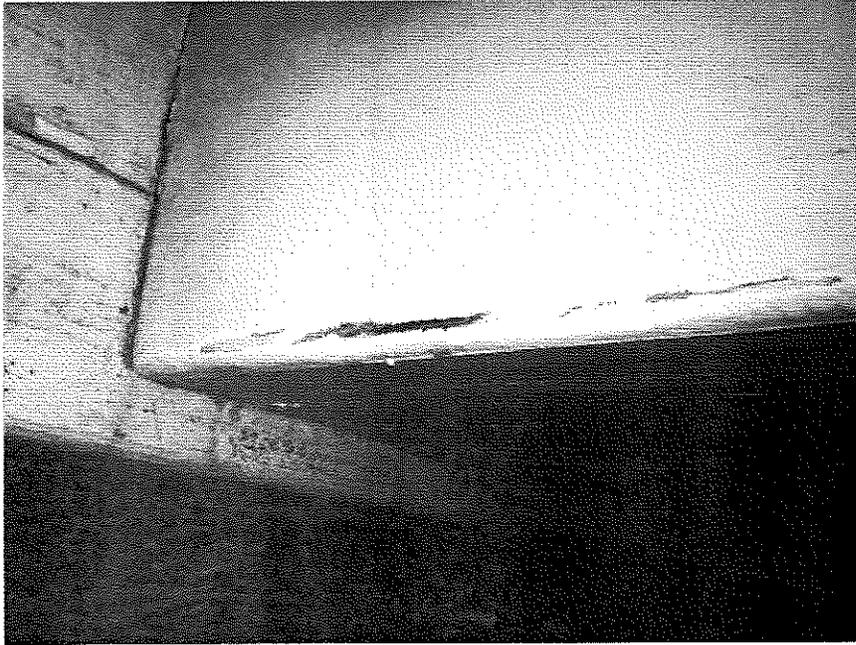
17) Engine room, carling, port side

White paint scraped back to reveal orange primer. Tested positive for lead

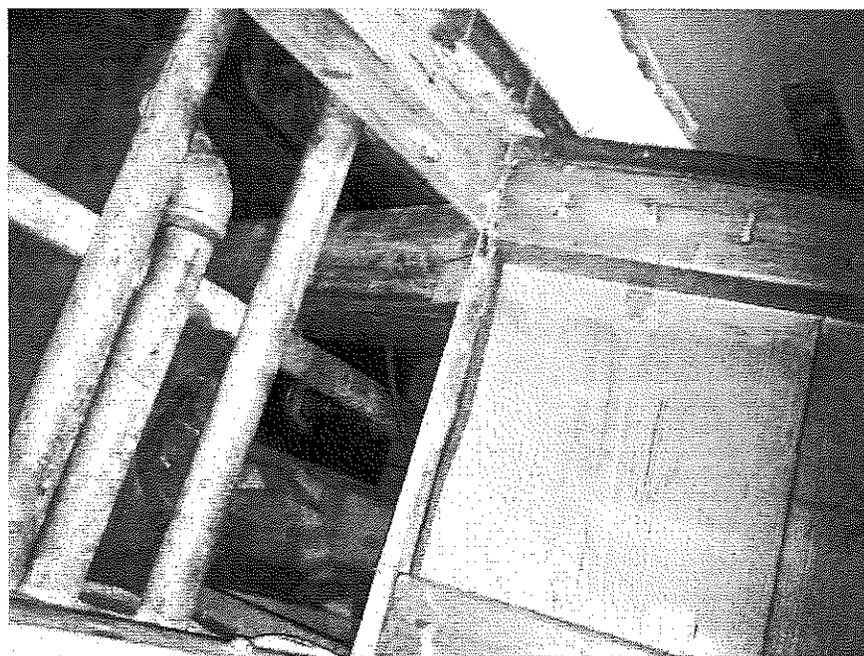
20) Five man, support station, port side aft

Exposed orange paint tested positive for lead

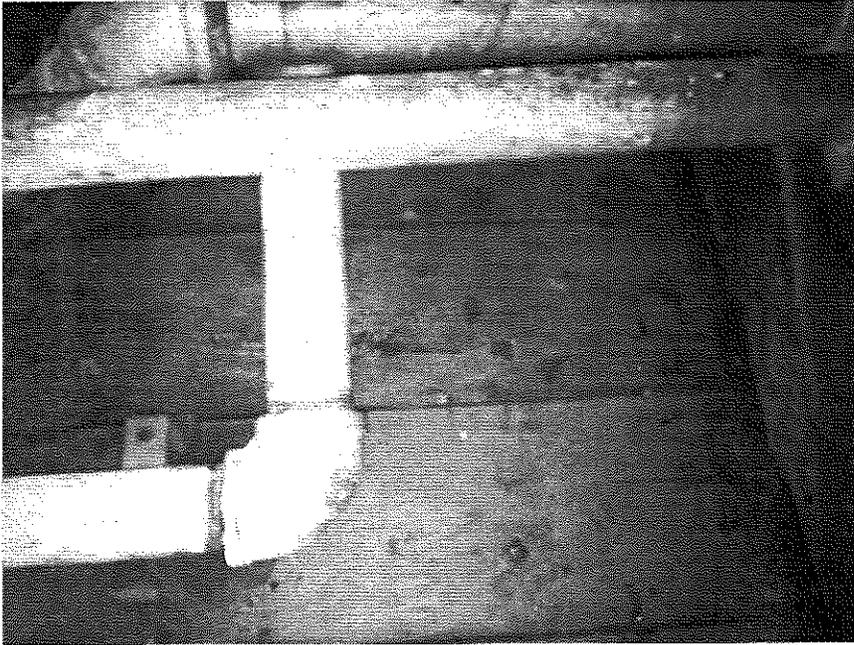
21) Five man, ceiling planking, port side

Exposed orange paint tested positive for lead

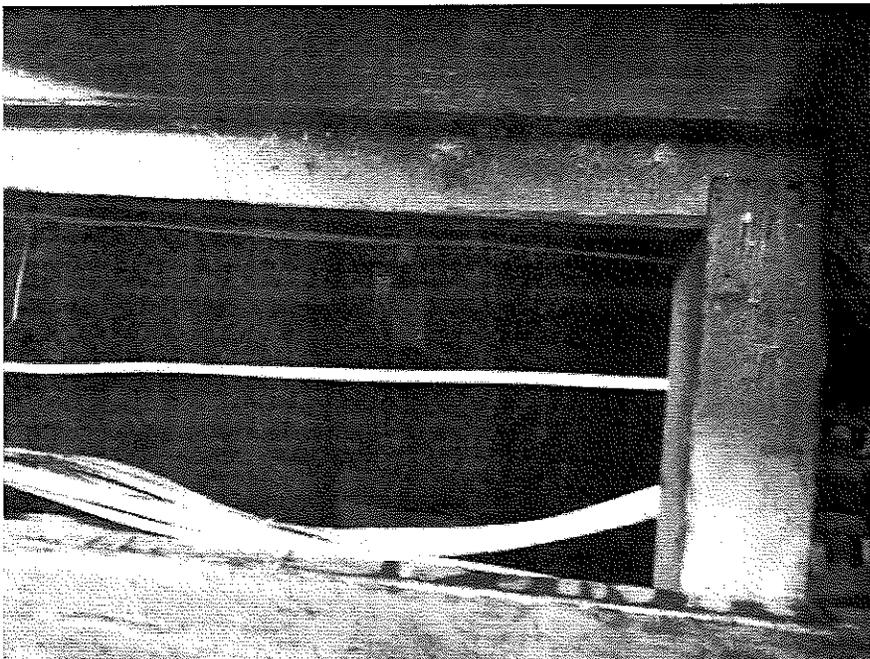
22) Ward room, steel shaft bearing support bracket, starboard side

Exposed orange paint tested positive for lead

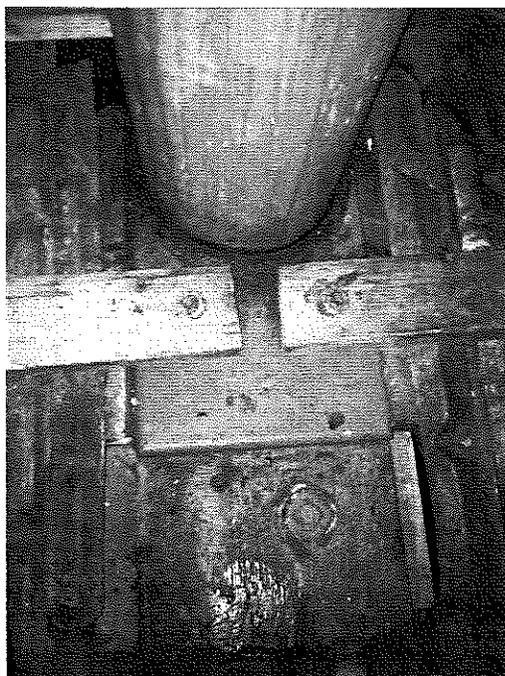
24) Capstan step

Exposed orange paint tested positive for lead
