**FINAL
HAZARDOUS MATERIALS SURVEY**

**STATE CORRECTIONAL INSTITUTION – PITTSBURGH
LAND USE FEASIBILITY STUDY
3001 BEAVER AVENUE
PITTSBURGH, PENNSYLVANIA 15233**

Project No. 2390

February 28, 2023

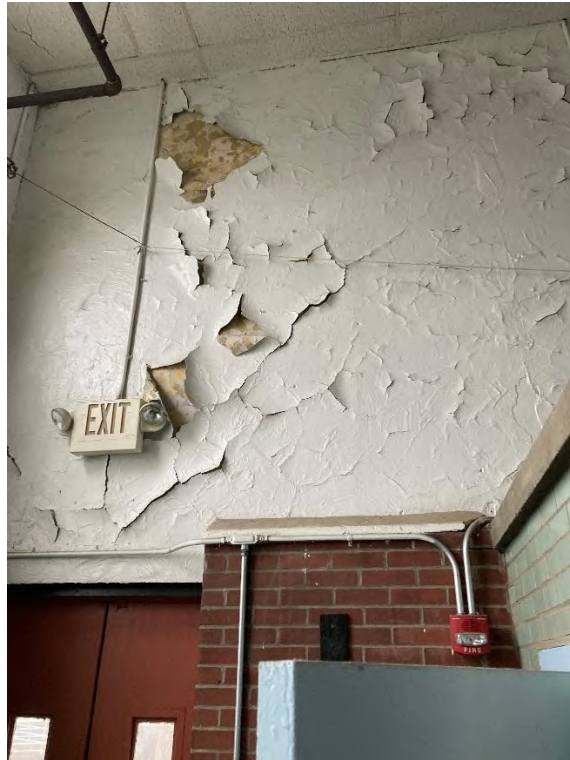
Photograph #2 | Positive ACM located in wall and ceiling plaster located in building 8

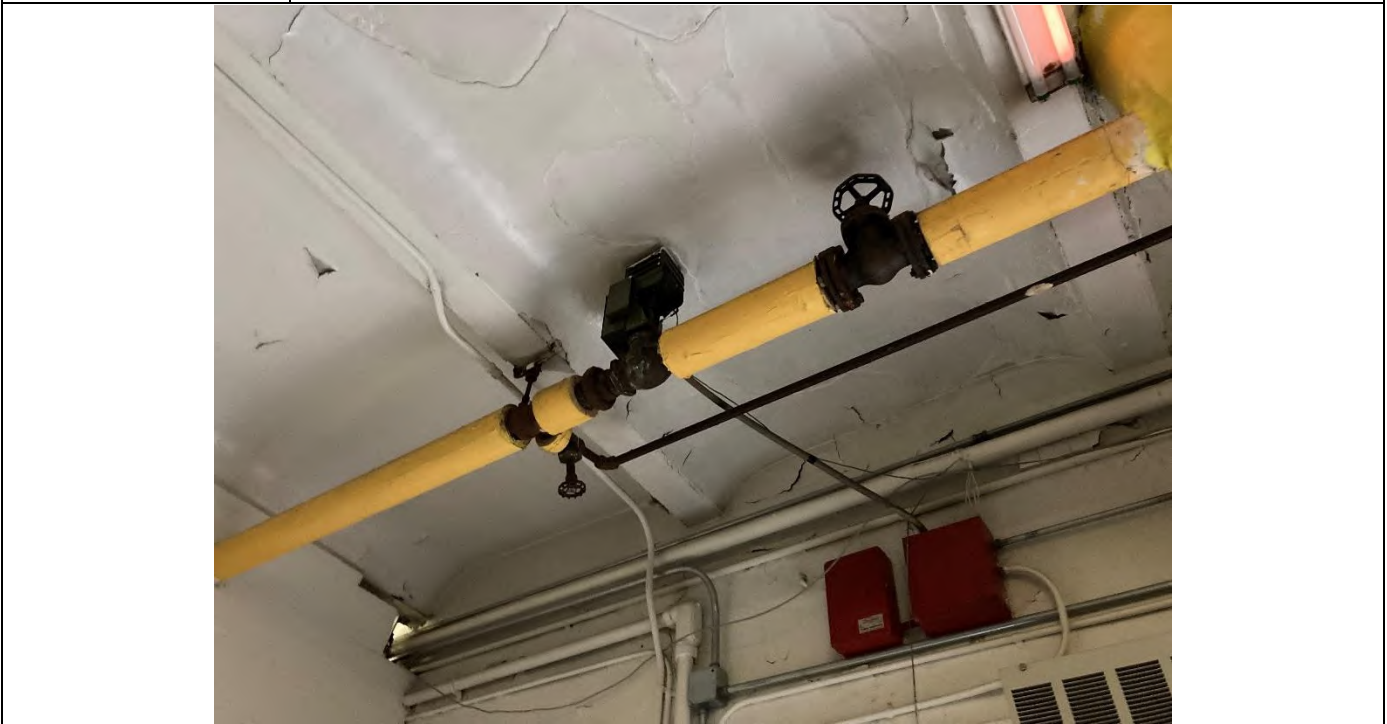
Photograph #2 | Positive ACM located in thermal surface insulation located in building 8A

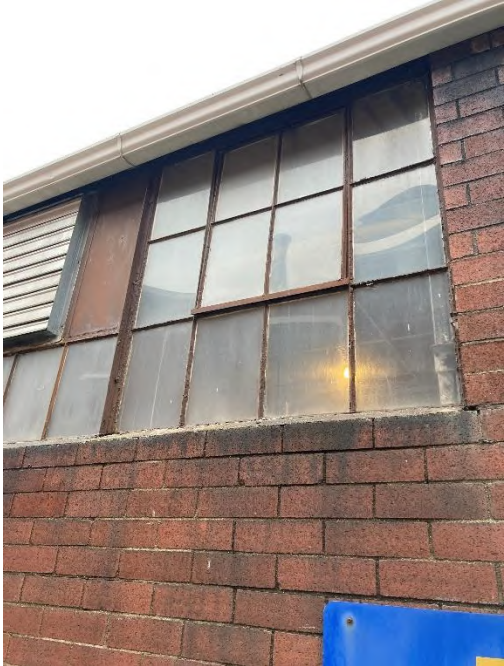
Photograph #2 | Positive ACM located in exterior window caulk located in building 10

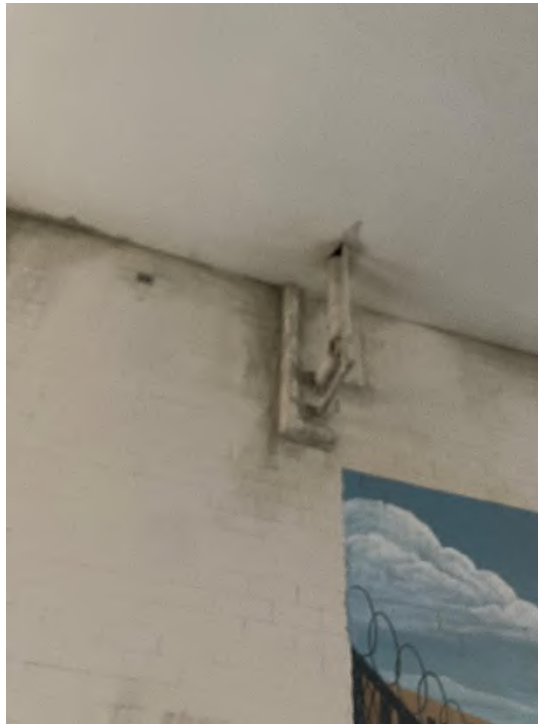
SCIP-43B	None Detected	Room 5			
44	Thermal Pipe Insulation	1" Mag Insulation on Various Diameter Pipe	Room 1, 3, 5, and Attic	Yes	SCIP-44A	44% Chrysotile	Room 1	Yes	425 Linear Feet	Damaged
					SCIP-44B	Not Analyzed	Room 3			
					SCIP-44C	Not Analyzed	Room 5			
45	Roofing Material	White Rubber Material and Sealant	Exterior Roof	No	SCIP-45A	None Detected	Exterior Roof	No	Not Applicable	Not Applicable
					SCIP45B	None Detected	Exterior Roof

Photograph #2 | Positive ACM located in thermal pipe insulation located in building 16, rooms 1, 3, and 5.

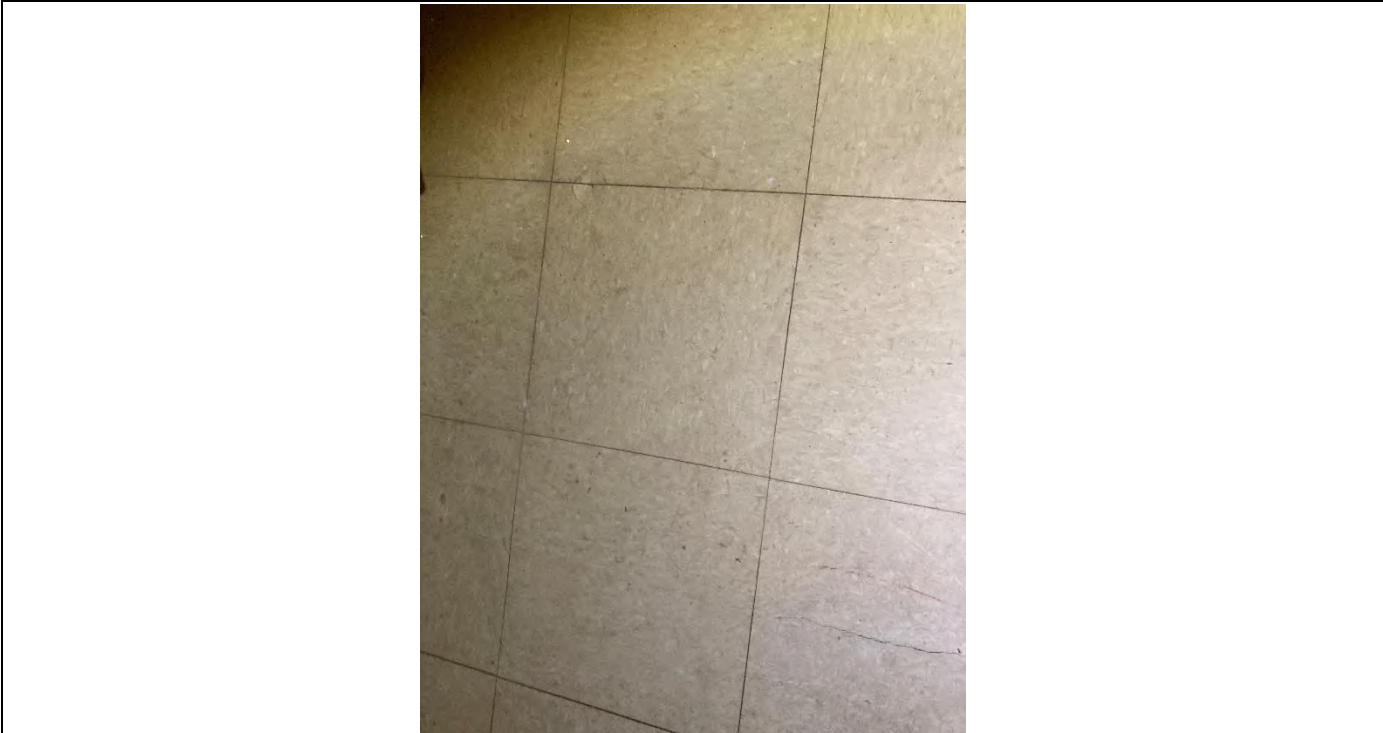
35	Vinyl Floor Tile with Floor Adhesive	9" x 9" Gray Vinyl Floor Tile with Black Floor Adhesive	Rooms 4, 31-36	No	SCIP-35A - Floor Tile SCIP-35A - Mastic SCIP-35B - Floor Tile SCIP-35B - Mastic	4% Chrysotile None Detected Not Analyzed None Detected	Room 4 Room 33	Yes	5,146 SQ FT	Damaged

Photograph #5	Positive ACM located in 9"x9" vinyl floor tile located in building 18, rooms 35 and 45.
----------------------	---

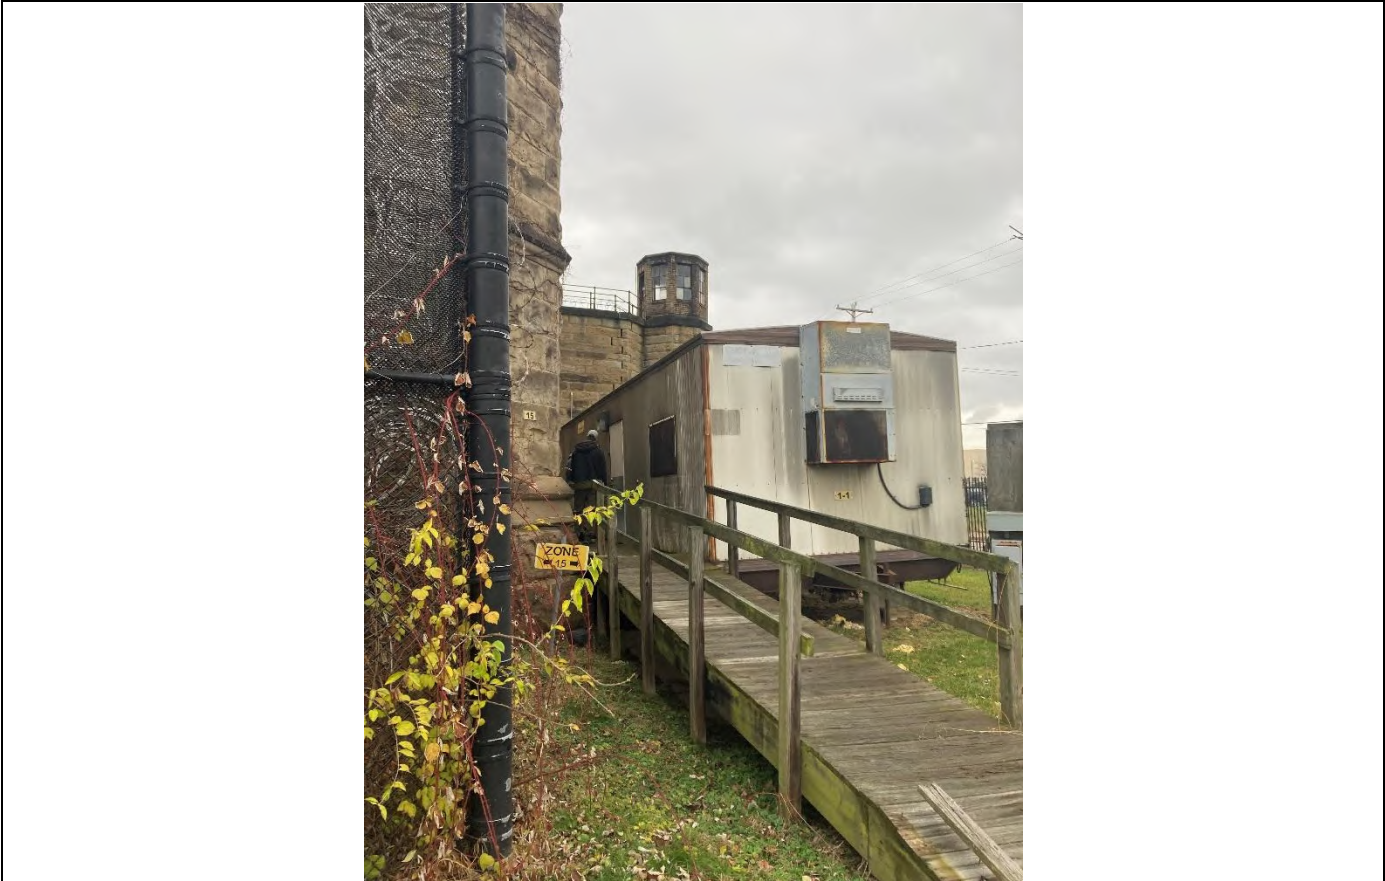
Photograph #1	SCIP Building 38 – Mail trailer. No ACM was detected in this building.
----------------------	--
