**FINAL
HAZARDOUS MATERIALS SURVEY**

**STATE CORRECTIONAL INSTITUTION – PITTSBURGH
LAND USE FEASIBILITY STUDY
3001 BEAVER AVENUE
PITTSBURGH, PENNSYLVANIA 15233**

Project No. 2390

February 28, 2023

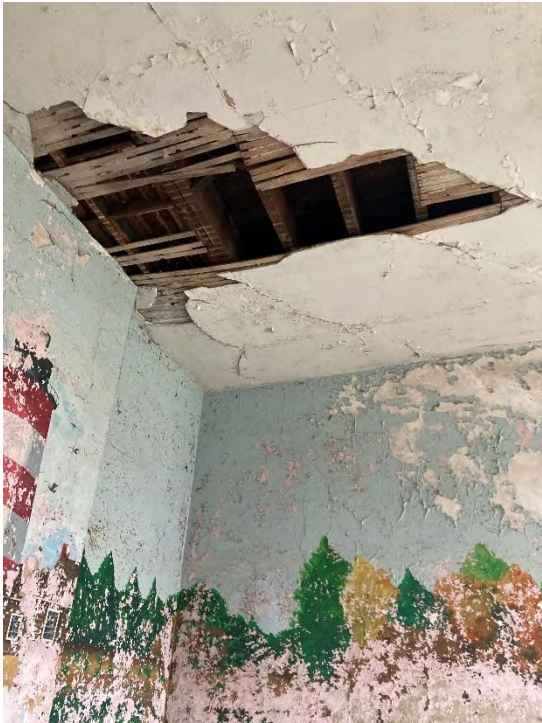
Photograph #2

Positive ACM located on the second floor of Building 1 – Front House.

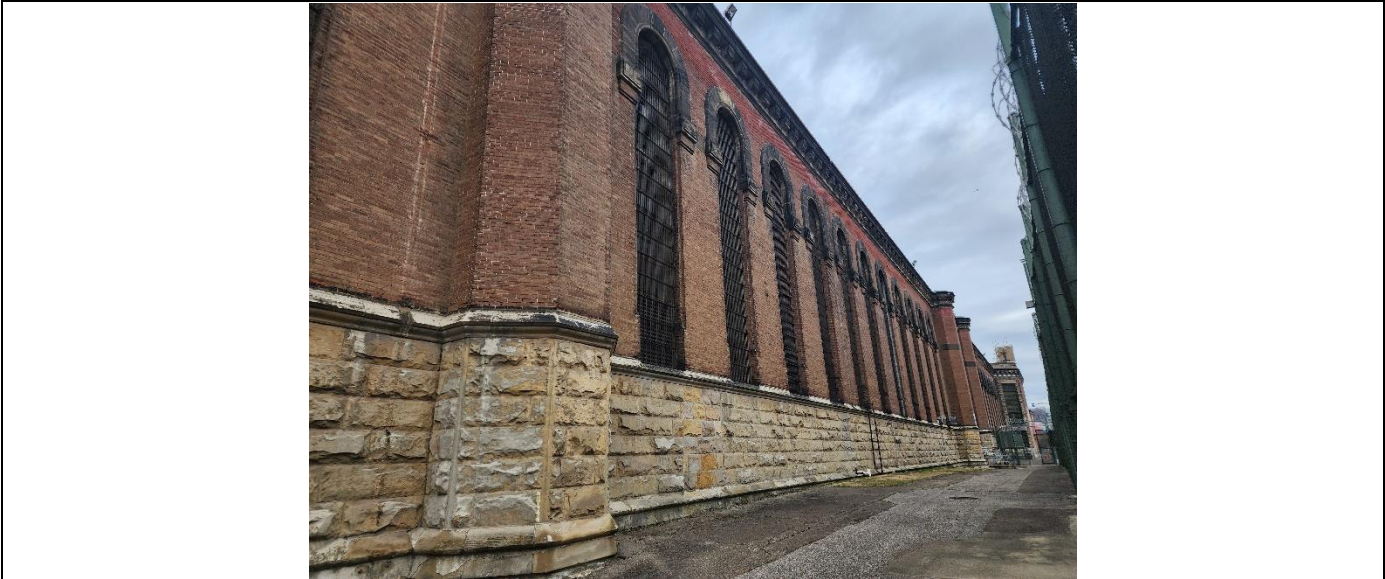
Photograph #1

SCIP Building 2 – Main Penitentiary Building North Wing. No ACM was detected in this building.

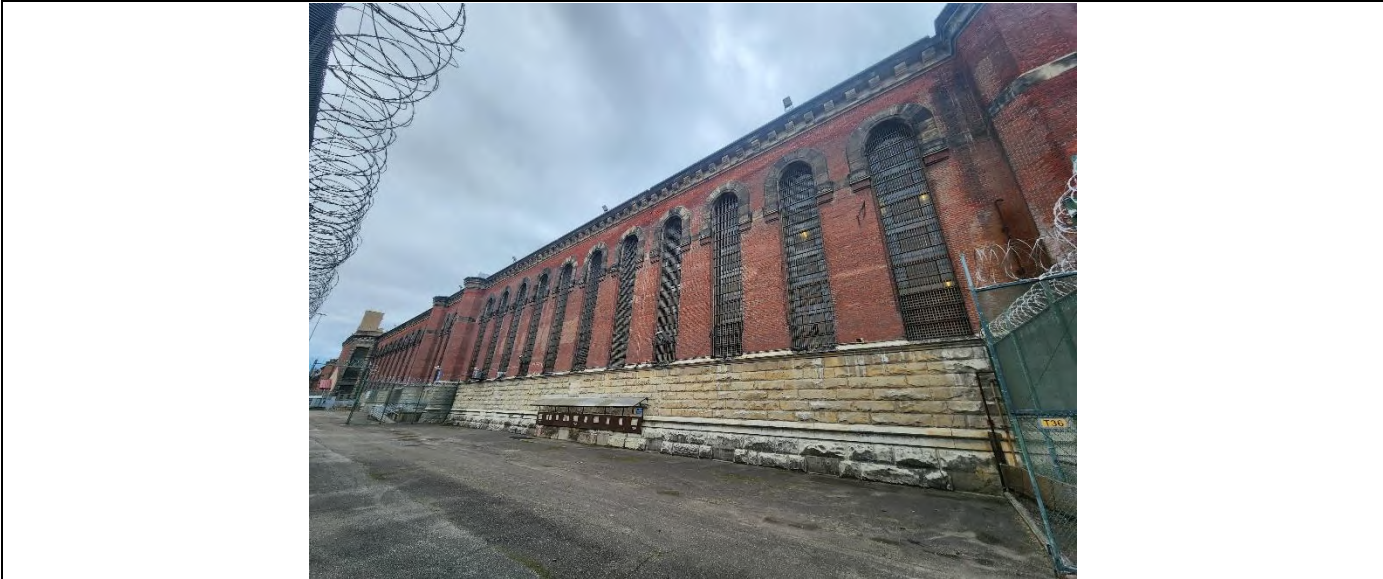
Photograph #1

SCIP Building 3 – Main Penitentiary Building South Wing. No ACM detected within this building.

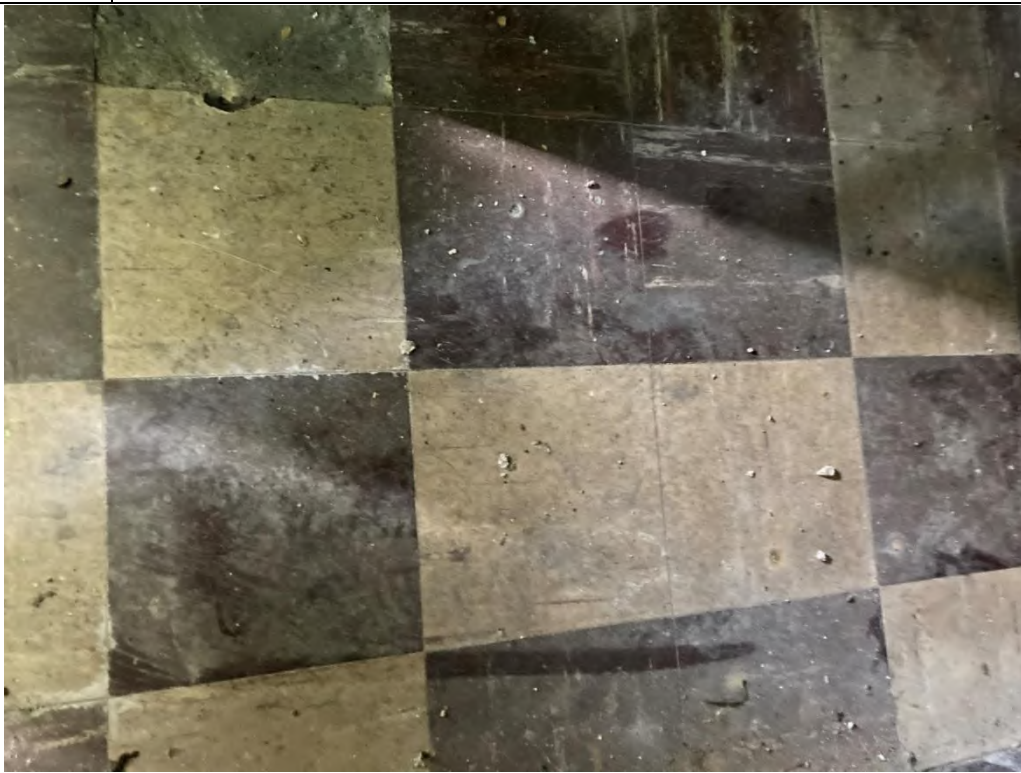
Photograph #2

Positive ACM located in 9'x9' white and brown vinyl floor tiles and adhesive located in Building 4.

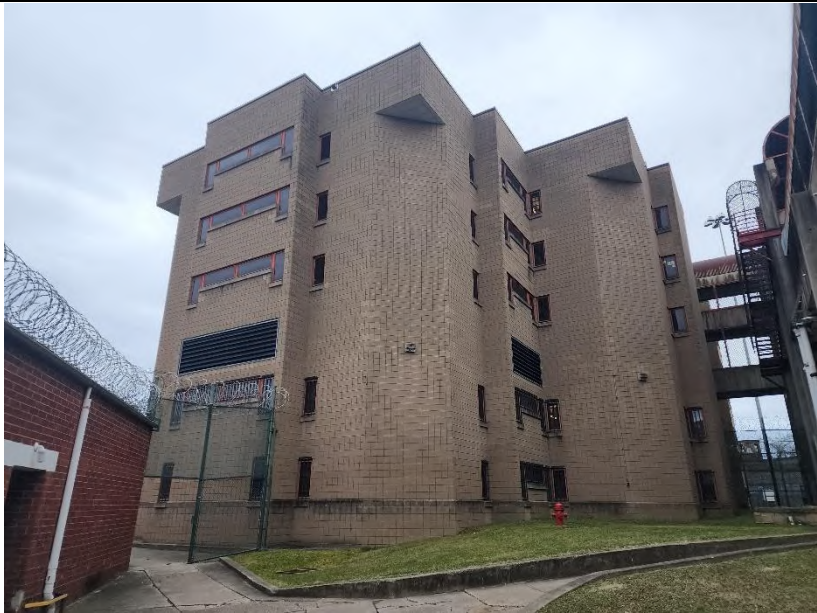
Photograph #1

SCIP Building 5 – Housing Unit A. No ACM was detected in this building.

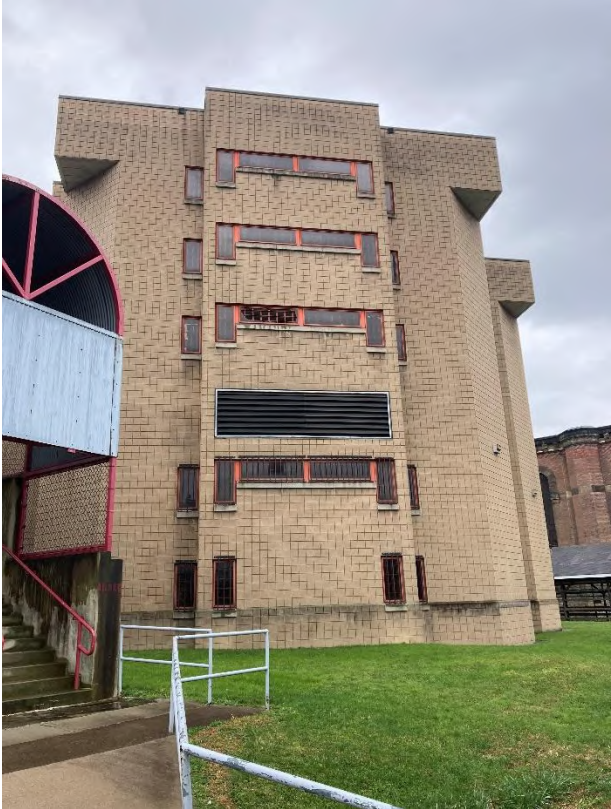
Photograph #1

SCIP Building 6 – Housing Unit B. No ACM was detected in this building.

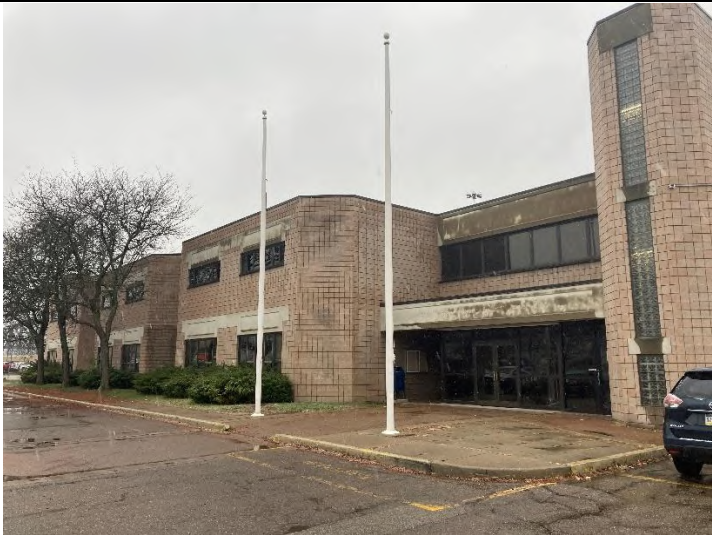
Photograph #1

SCIP Building 7 – Administrative Complex. No ACM was detected in this building.

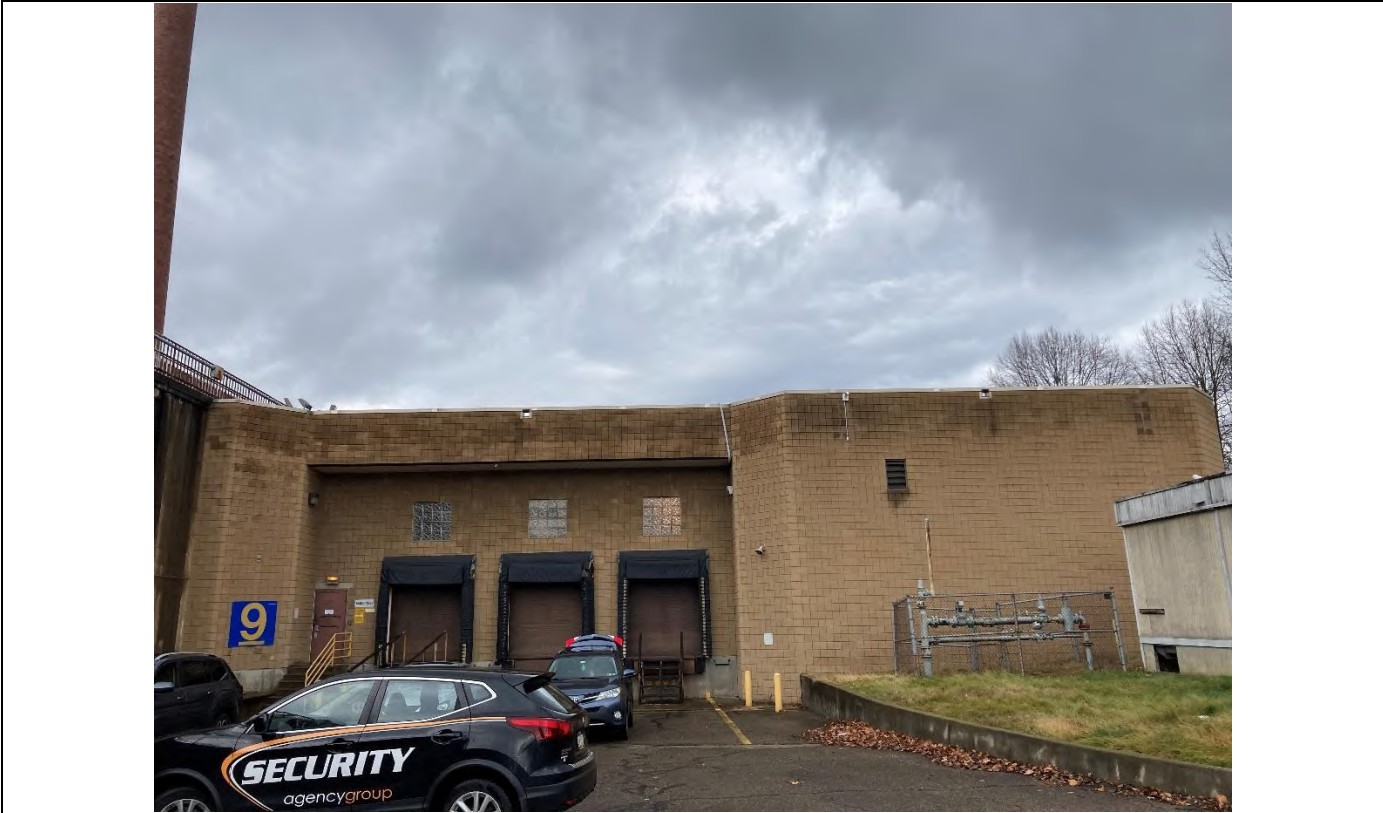
Photograph #1

SCIP Building 9 – Institution Warehouse. No ACM was detected in this building.

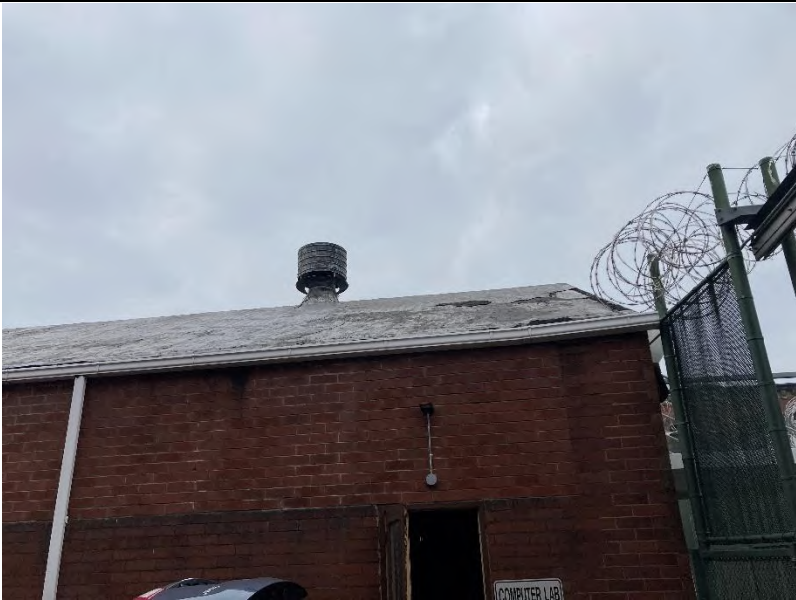
Photograph #3

Positive ACM located in asphaltic roofing membrane located in building 10

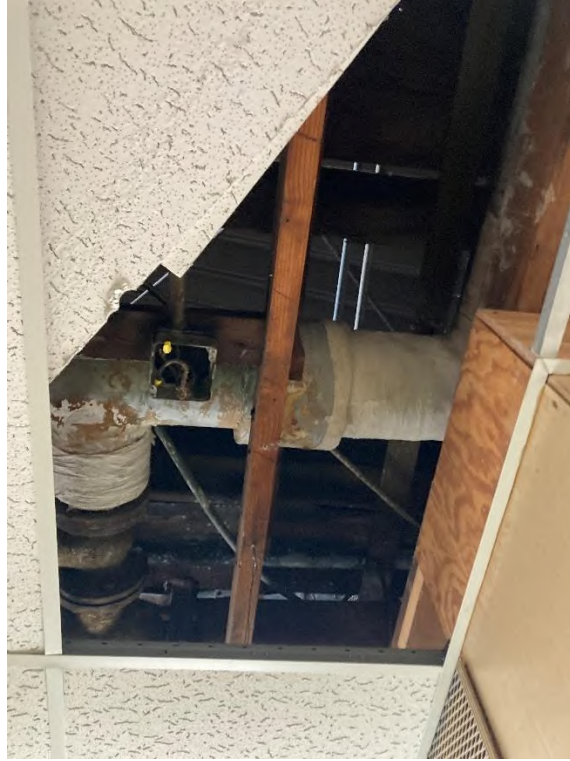
Photograph #3

Positive ACM located in thermal pipe insulation located in building 11

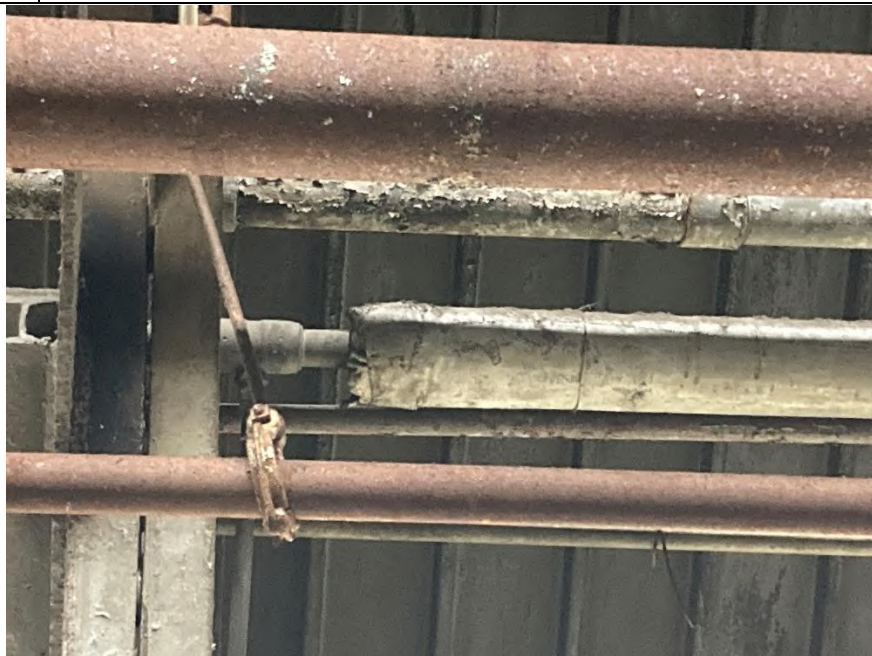
Photograph #4

Positive ACM located in thermal pipe insulation located in building 11

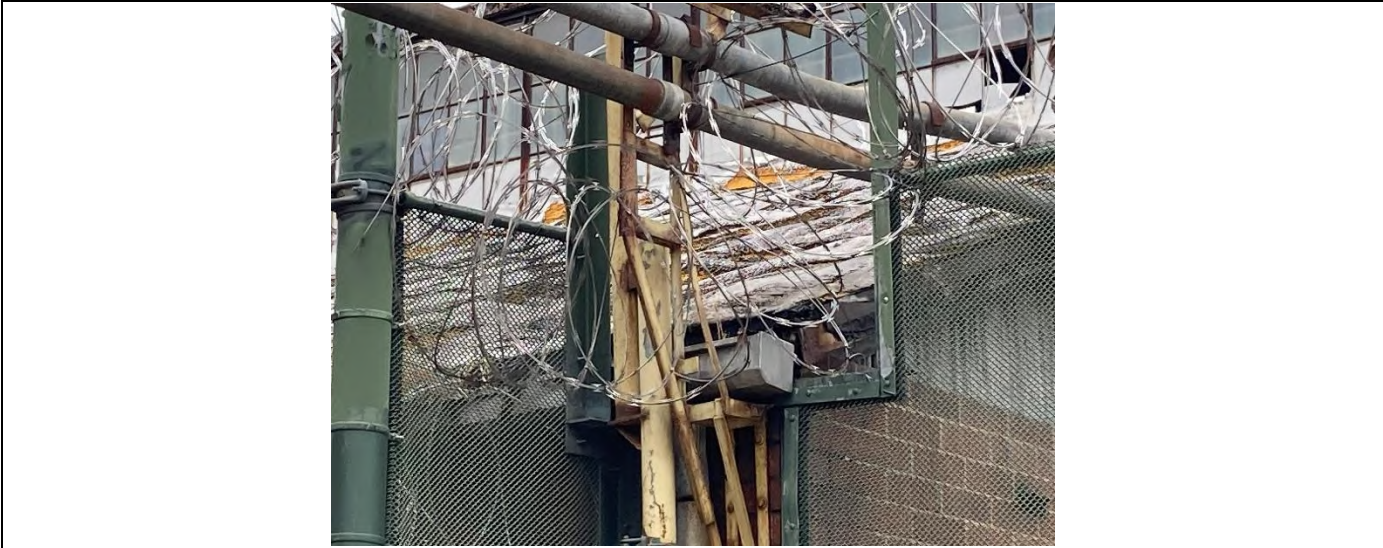
Photograph #5

Positive ACM located in asphaltic roof material located in building 11

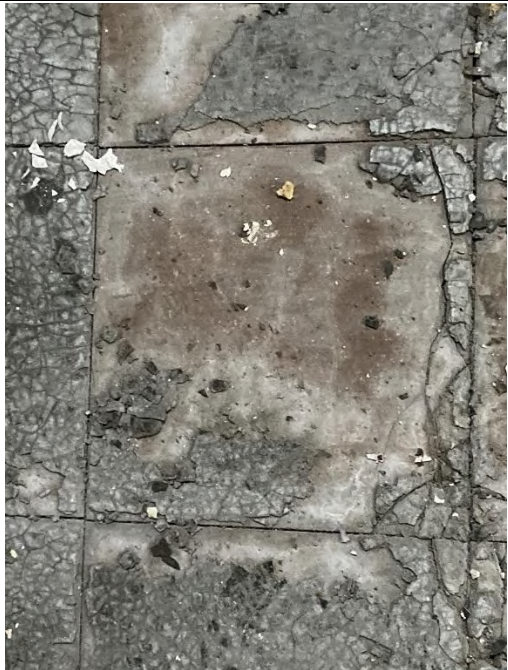
Photograph #2

Positive ACM located in 9"x9" brown vinyl floor tile and adhesive located in building 12.

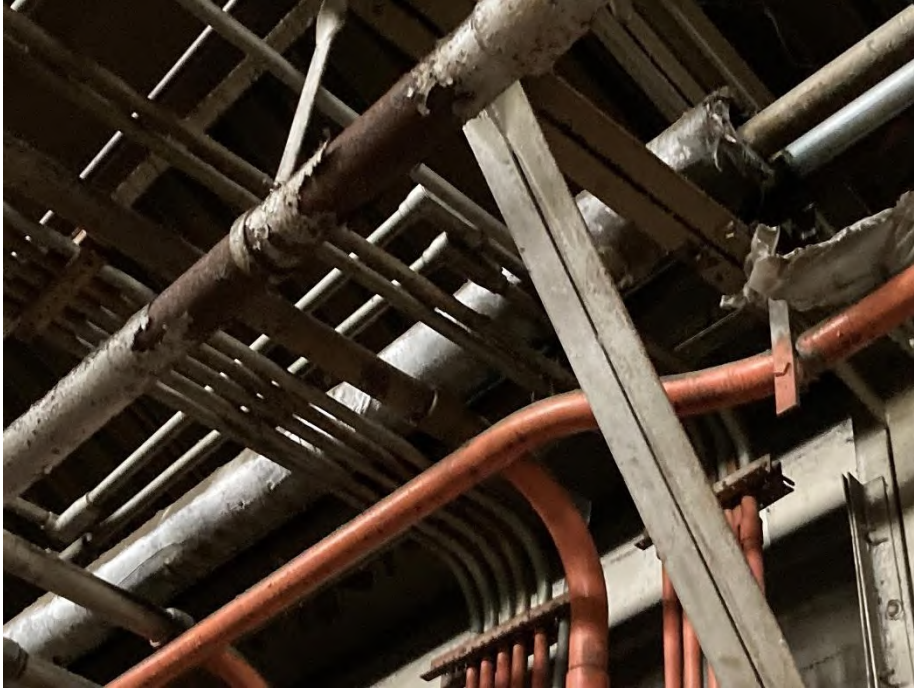
Photograph #3

Positive ACM located in thermal pipe insulation located in building 12.

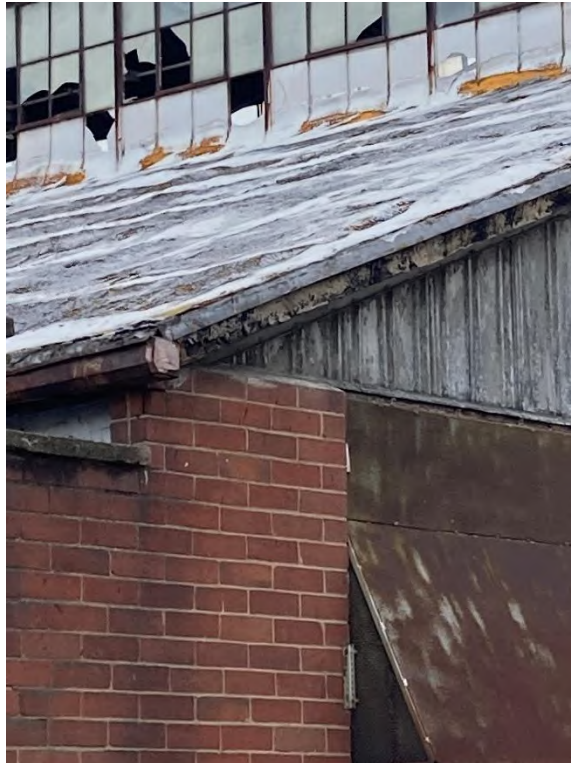
Photograph #4

Positive ACM located in asphaltic roof material located in building 12.

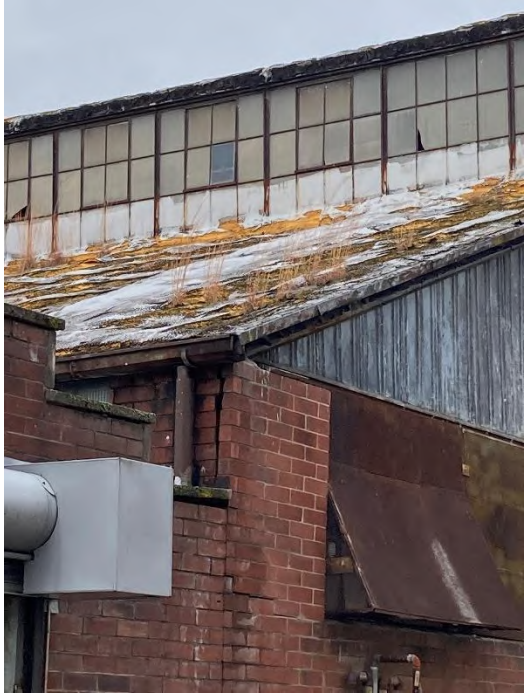
Photograph #3

Positive ACM located in asphaltic roof material located in building 13.

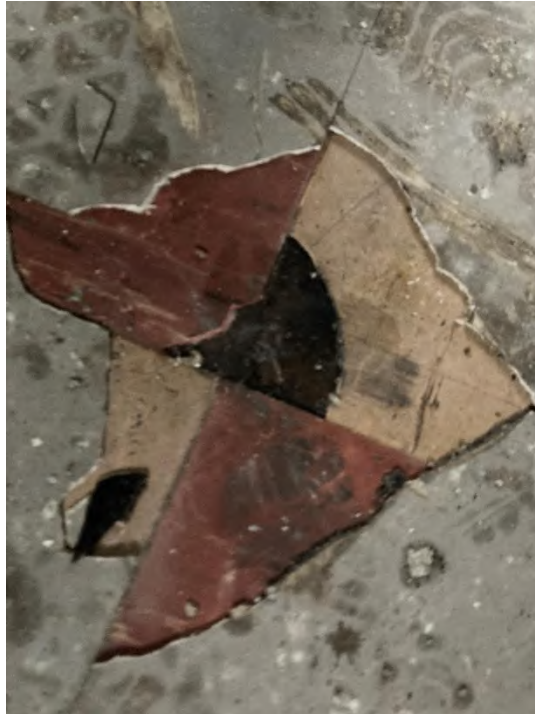
Photograph #2

Positive ACM located in 9"x9" red and 9"x9" brown floor tile and adhesive located in building 14, rooms 1 and 2.

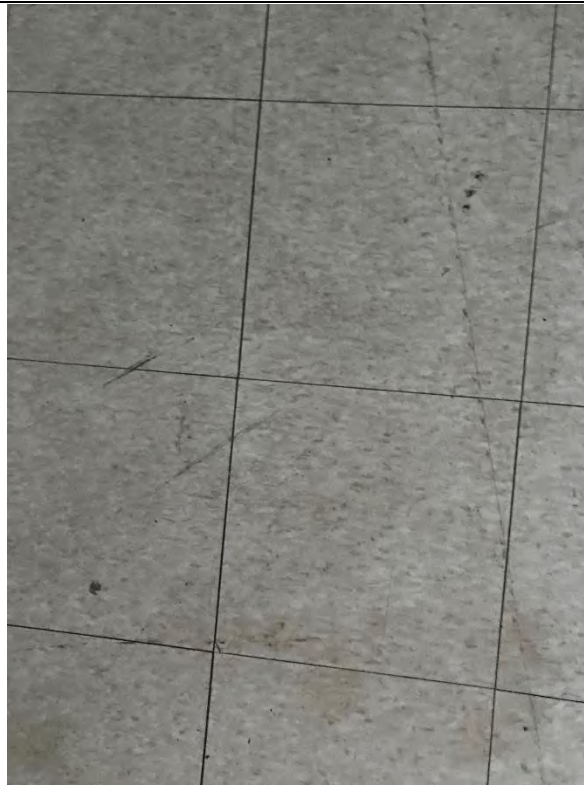
Photograph #2

Positive ACM located in 12"x12" gray floor tile and adhesive located in building 15, room 1.

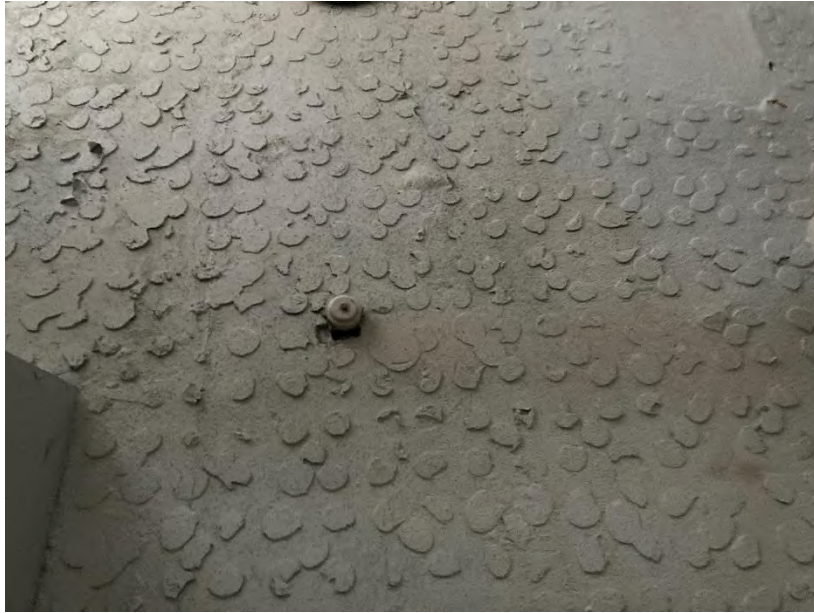
Photograph #3

Positive ACM located in ceiling tile adhesive located in building 15, room 13.

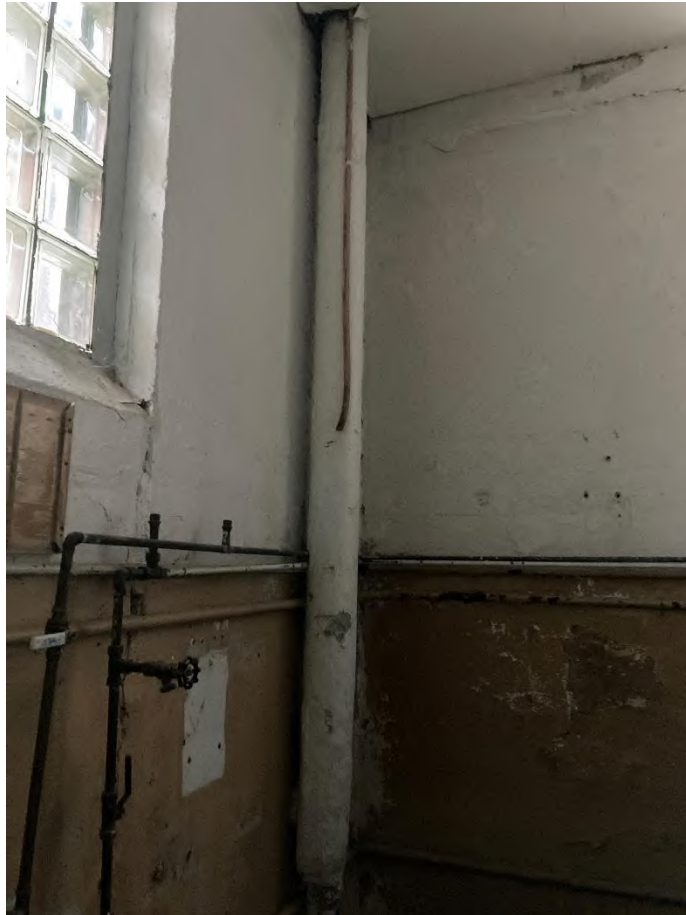
Photograph #4

Positive ACM located in thermal pipe insulation located in building 15, rooms 3 and 8.

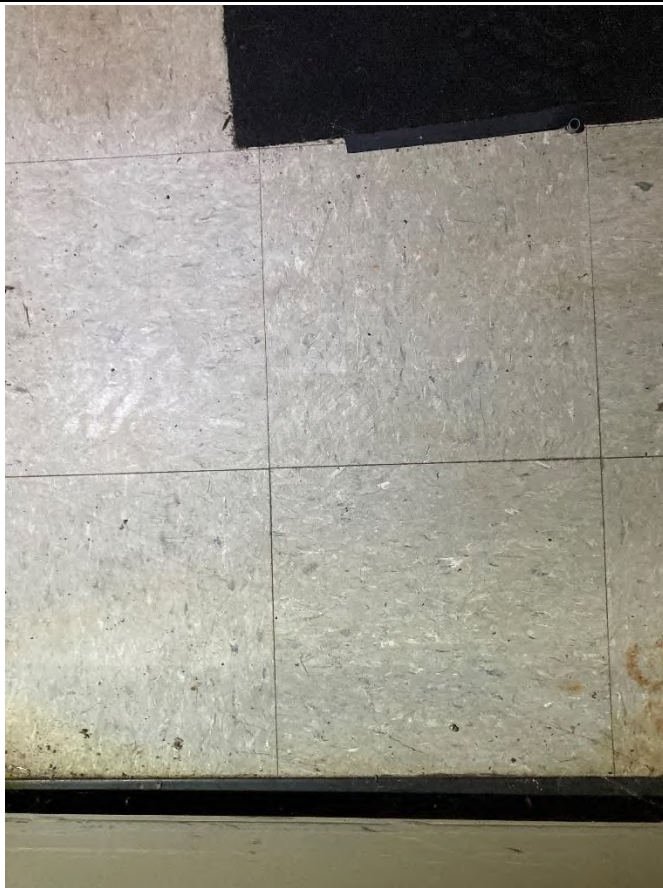
Photograph #2

Positive ACM located in 12"x12" gray floor tile and adhesive located in building 18, room 1.

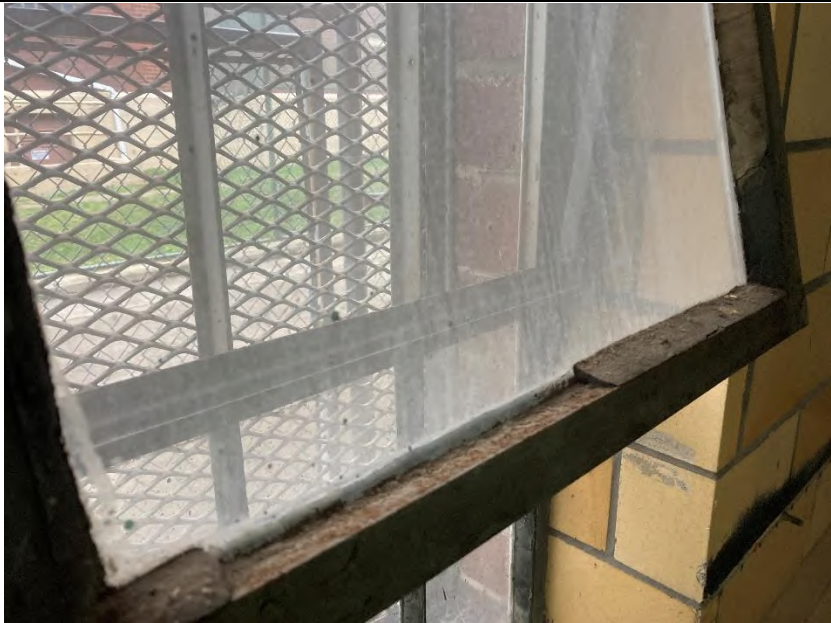
Photograph #3

Positive ACM located in window caulk in building 18.

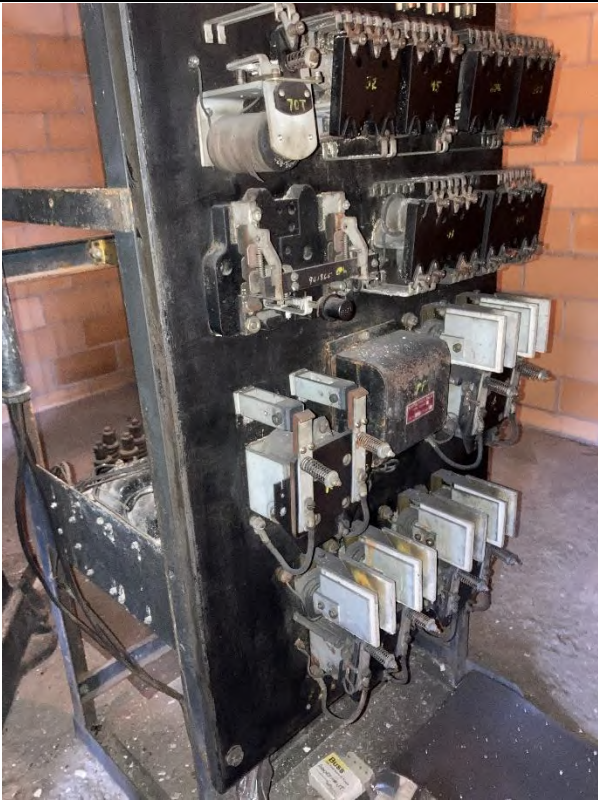
Photograph #4

Positive ACM located in cement pads located in building 18, elevator room.

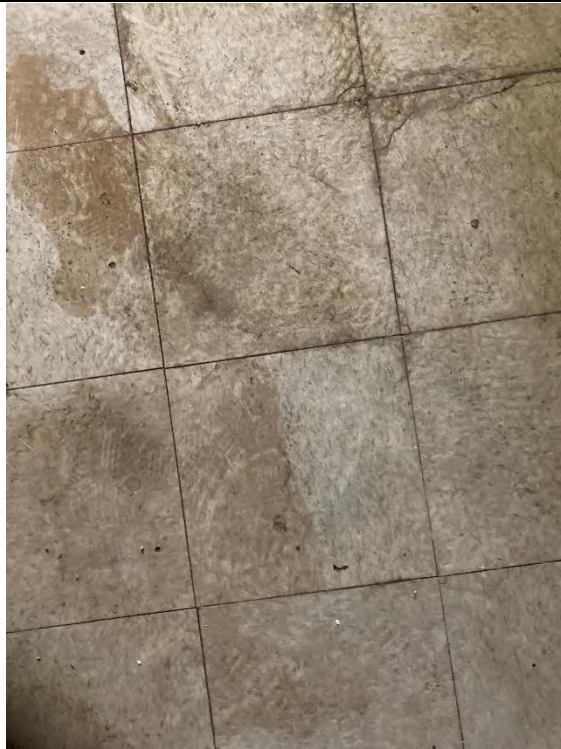
Photograph #2

Positive ACM located in 12"x12" tan floor tile and adhesive located in building 23, room 4.

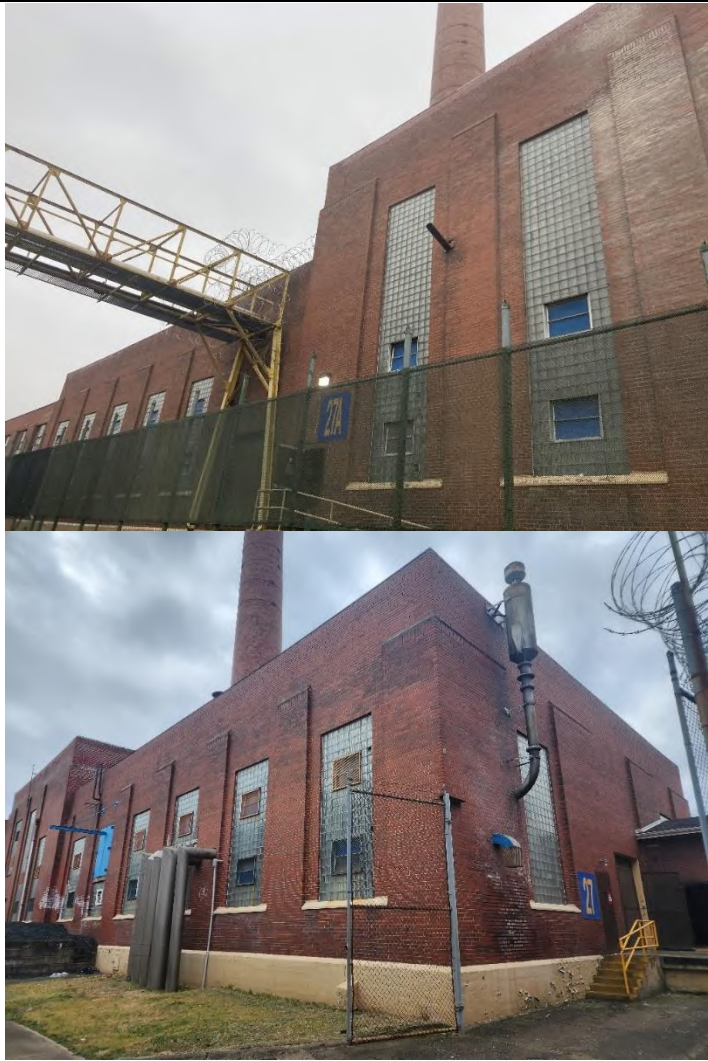
Photograph #1

SCIP Building 27A – Boiler Plant and Power House.

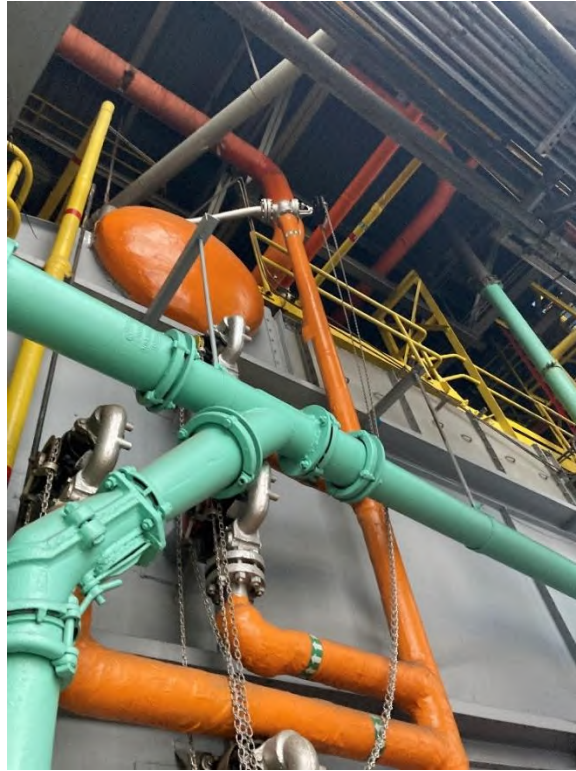
Photograph #2

Positive ACM located in Cal Mag and boiler insulation in building 27A, room 9.

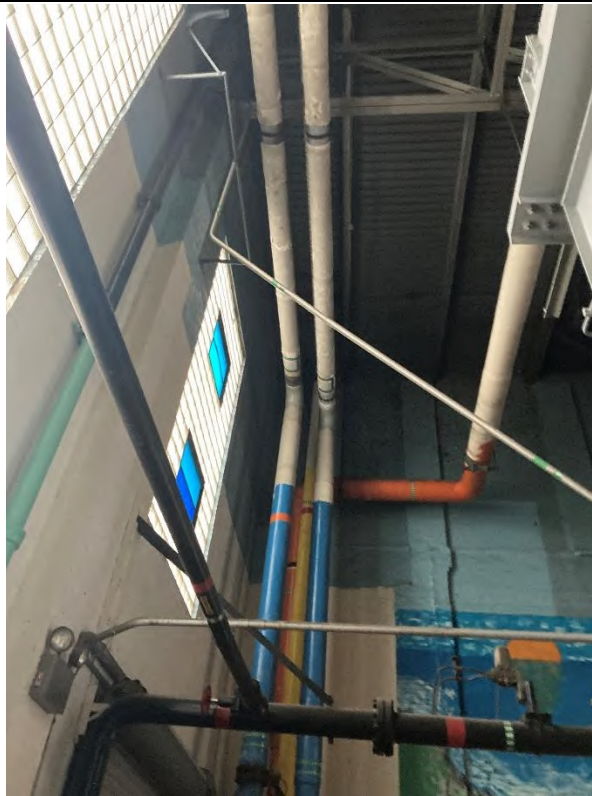
Photograph #3

Positive ACM located in Aircell insulation in building 27A, room 9.

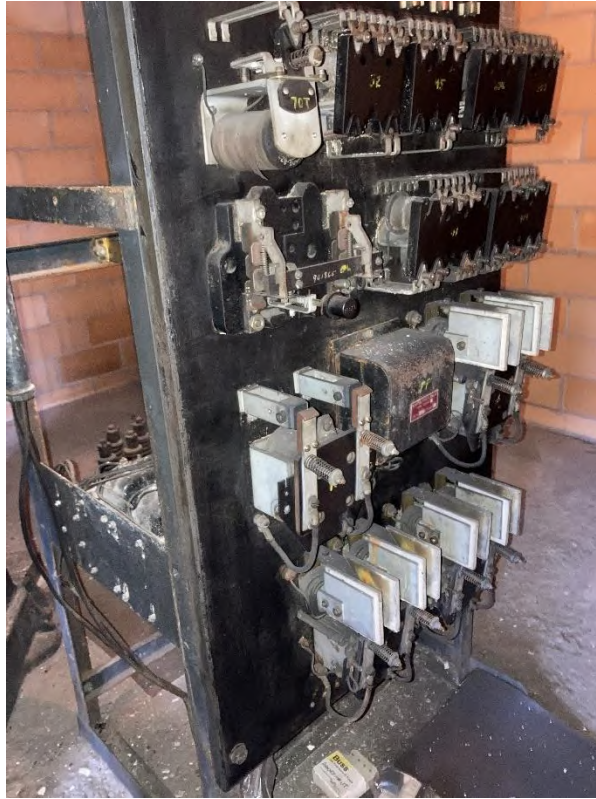
Photograph #4

Positive ACM located in cement pads located in building 18, elevator room.

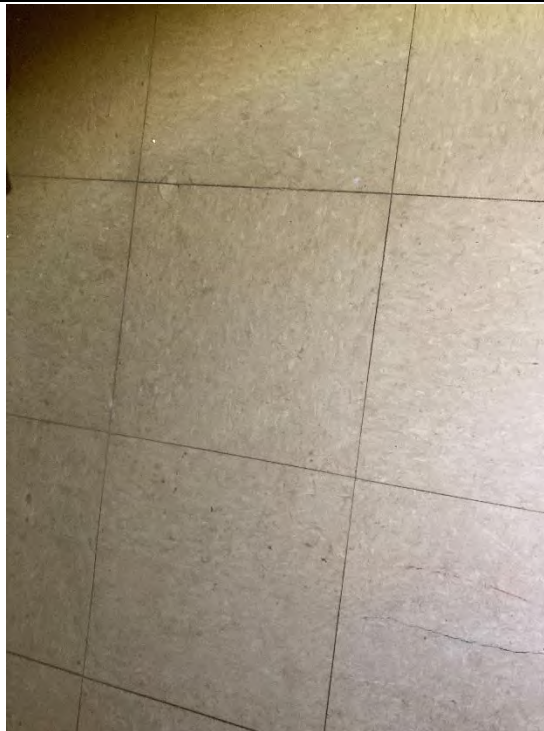
Photograph #5

Positive ACM located in 9"x9" vinyl floor tile located in building 18, rooms 35 and 45.

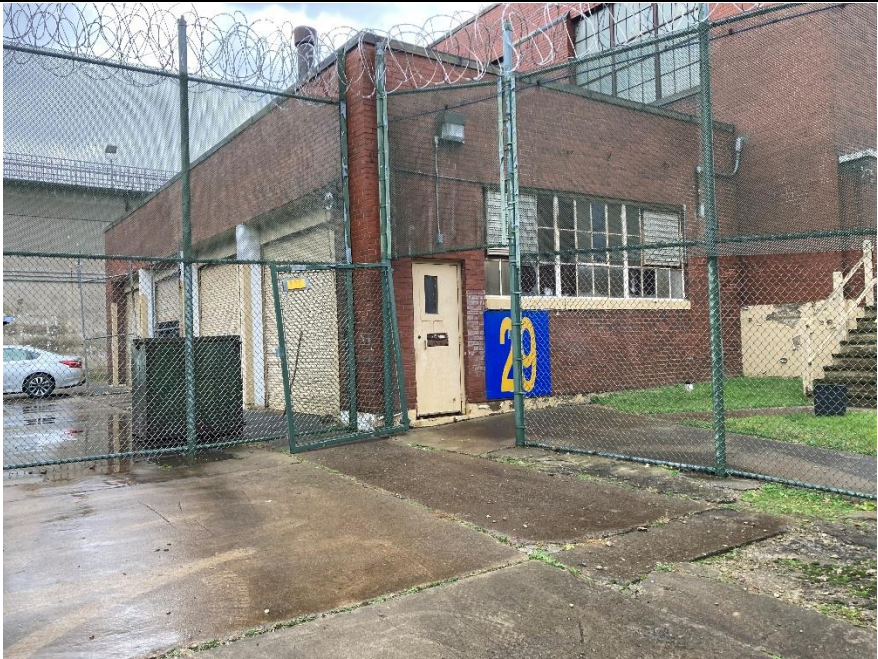
Photograph #1

SCIP Building 29 – Welding Shop. No ACM was detected in this building.

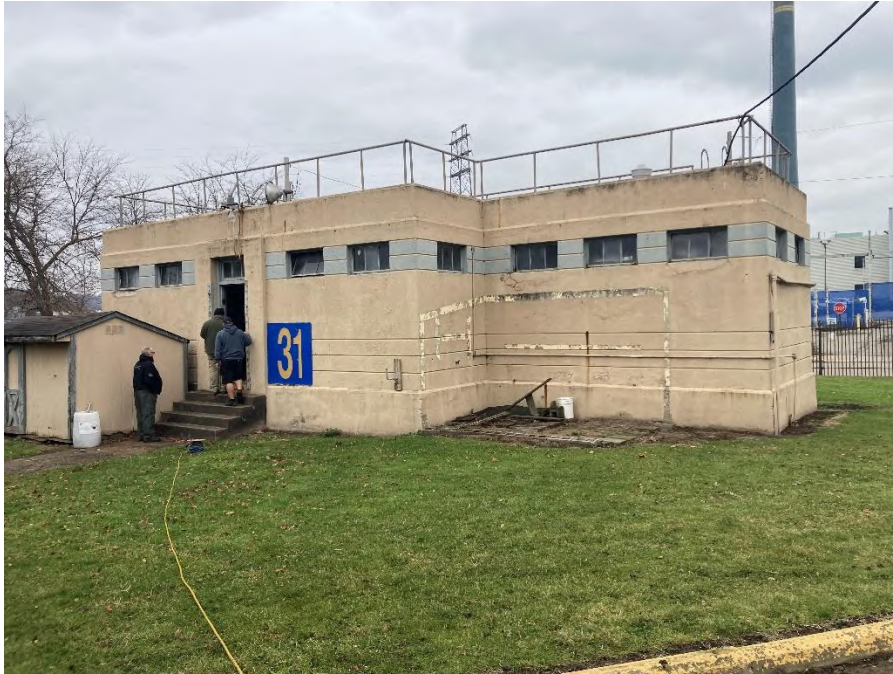
Photograph #1

SCIP Building 31 – Sewage Pump House.

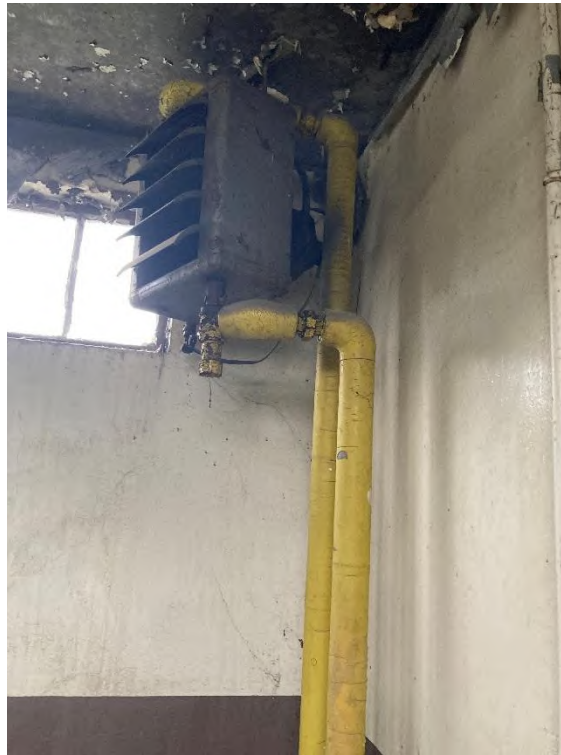
Photograph #2

As a result of the Hazardous Materials Survey conducted at SCIP, three suspected asbestos-containing materials were sampled and analyzed in Building 31 – Sewage Pump House of SCIP. One homogeneous material tested positive for asbestos. The material was Thermal Pipe Insulation (Material 231). This material was observed to be in a damaged condition. Specific information pertaining to each of the materials sampled, including the results of the sample analysis, can be found on the Asbestos Survey Material Summary below.

Positive ACM located in thermal pipe insulation in building 31, rooms 1, 2, and 5.

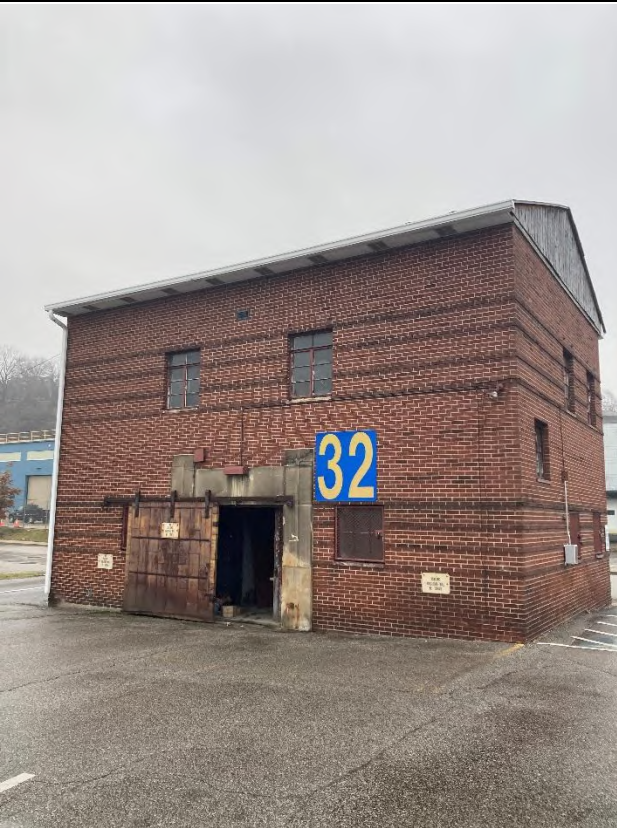
Photograph #1

SCIP Building 32 – Maintenance Storage House.

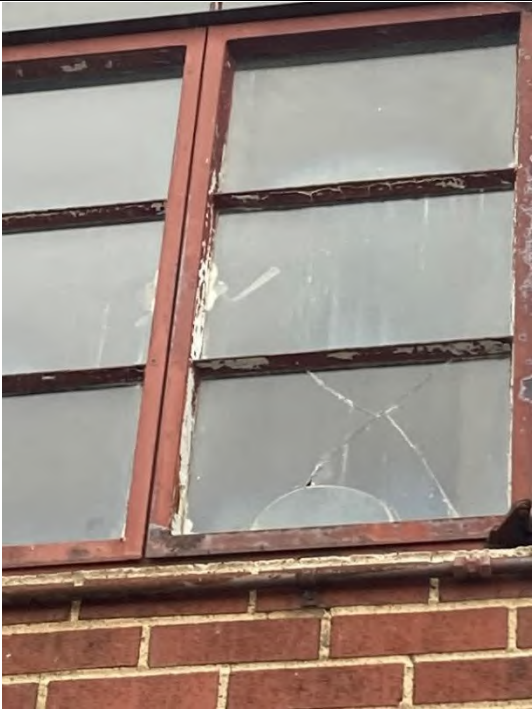
Photograph #2

As a result of the Hazardous Materials Survey conducted at SCIP, three suspected asbestos-containing materials were sampled and analyzed in Building 32 – Maintenance Storage Building of SCIP. One homogeneous material tested positive for asbestos. The material was Window Caulk (Material 207). This material was observed to be in a damaged condition. Specific information pertaining to each of the materials sampled, including the results of the sample analysis, can be found on the Asbestos Survey Material Summary below.

Positive ACM located in window caulk in building 32.

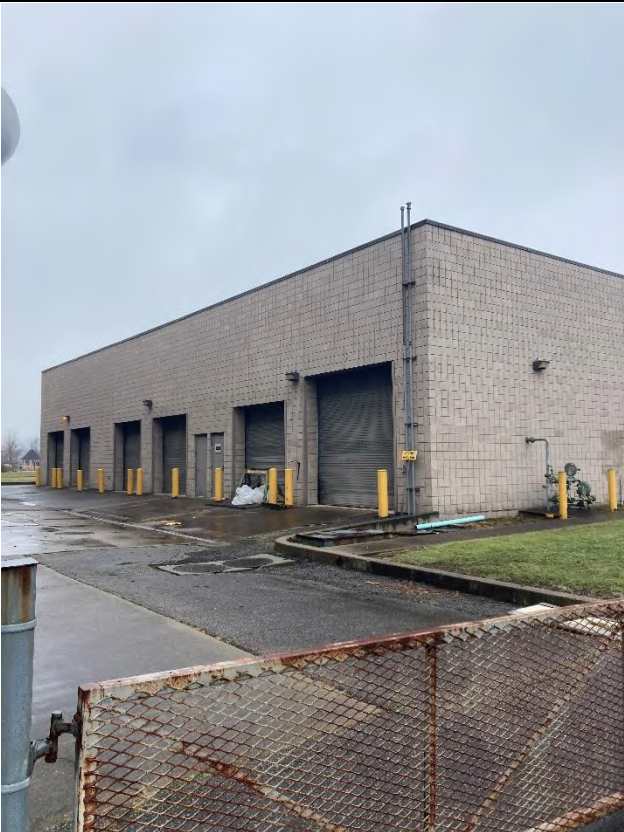
Photograph #1

SCIP Building 35 – Vehicle Maintenance. No ACM was detected in this building.

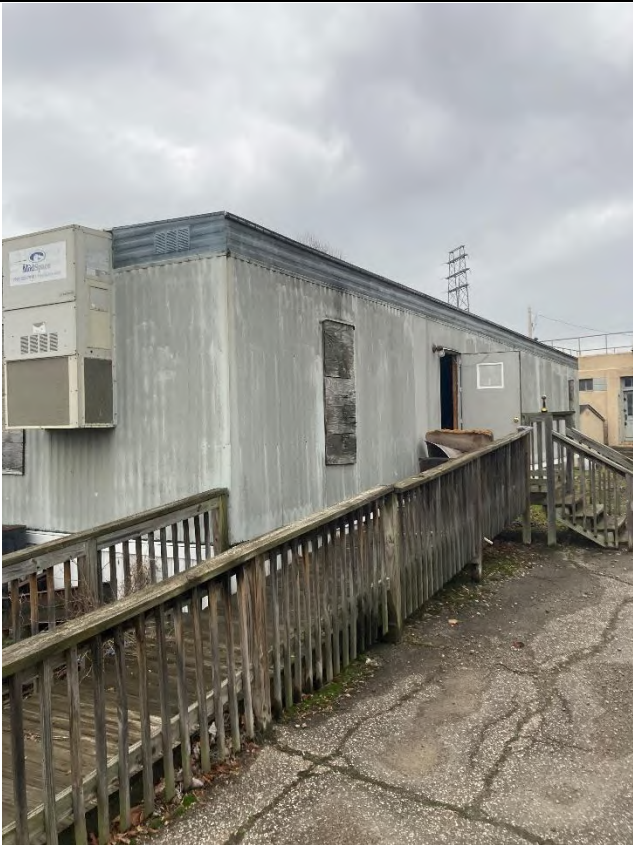
Photograph #1

SCIP Building 36 – Modular Building. No ACM was detected in this building.

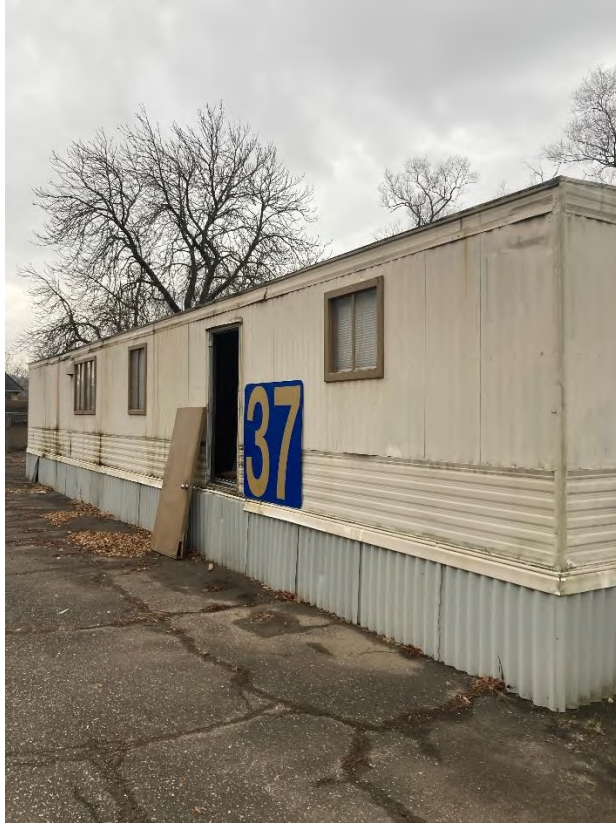
Photograph #1

SCIP Building 37 – Modular Building.

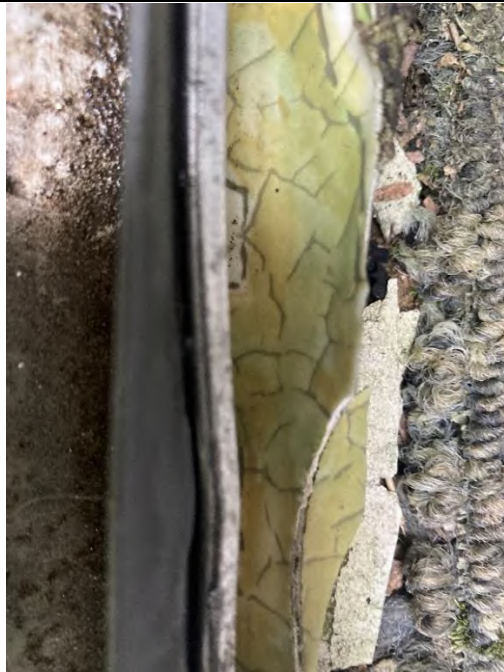
Photograph #2

As a result of the Hazardous Materials Survey conducted at SCIP, two suspected asbestos-containing materials were sampled and analyzed in Building 37 – Modular Building of SCIP. One homogeneous material tested positive for asbestos. The material was Vinyl Floor Sheeting with Floor Adhesive (Material 233). This material was observed to be in a damaged condition. Specific information pertaining to each of the materials sampled, including the results of the sample analysis, can be found on the Asbestos Survey Material Summary below.

Positive ACM located in vinyl floor surface and adhesive in building 37.

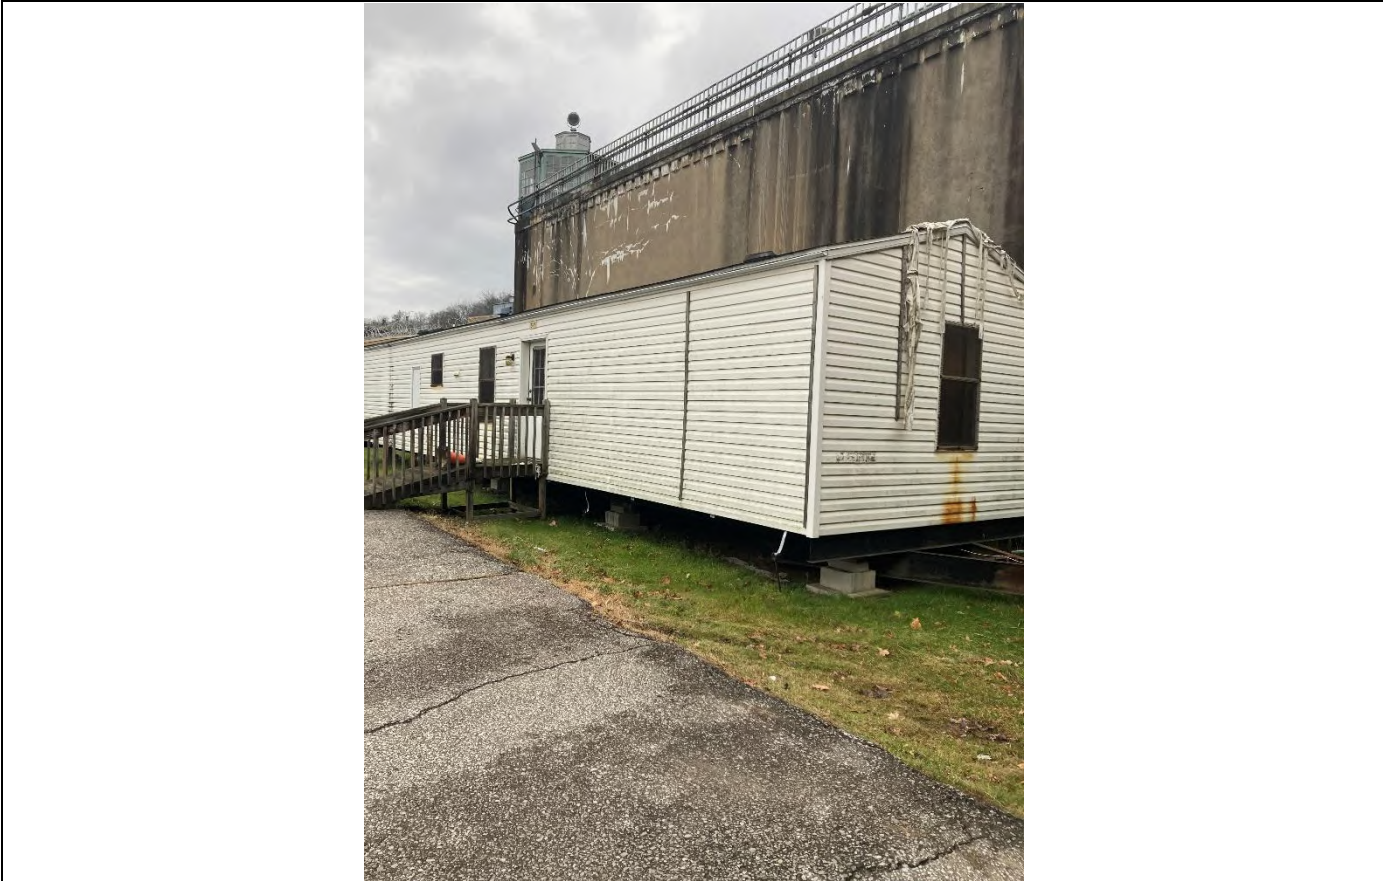
Photograph #1	SCIP Building 39 – CERT. No ACM was detected in this building.
----------------------	--
