**FINAL
HAZARDOUS MATERIALS SURVEY**

**STATE CORRECTIONAL INSTITUTION – PITTSBURGH
LAND USE FEASIBILITY STUDY
3001 BEAVER AVENUE
PITTSBURGH, PENNSYLVANIA 15233**

Project No. 2390

February 28, 2023

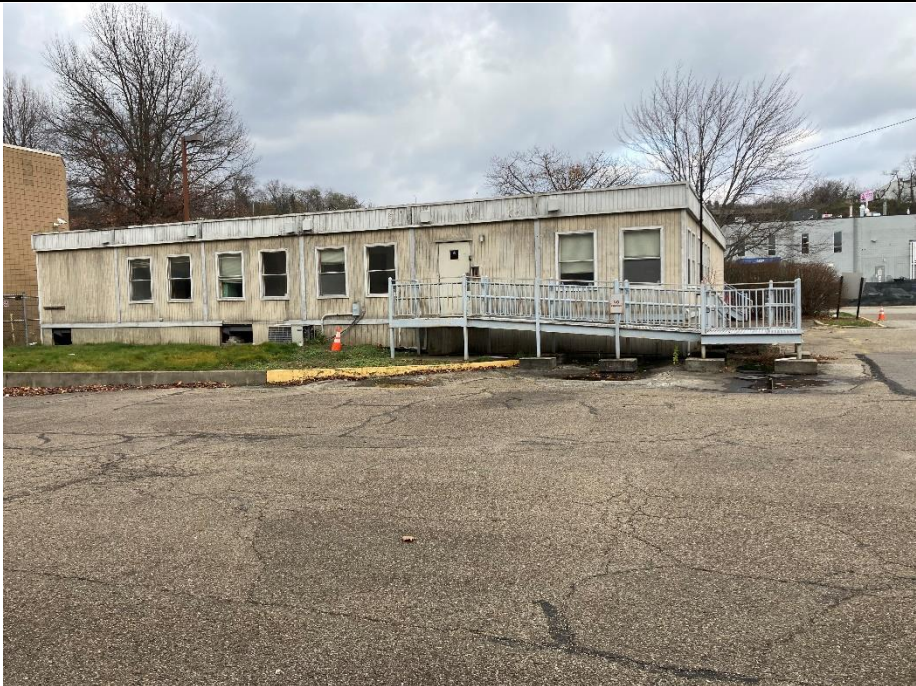
Photograph #1

SCIP Building 42 – Staff Lockers. No ACM was detected in this building.

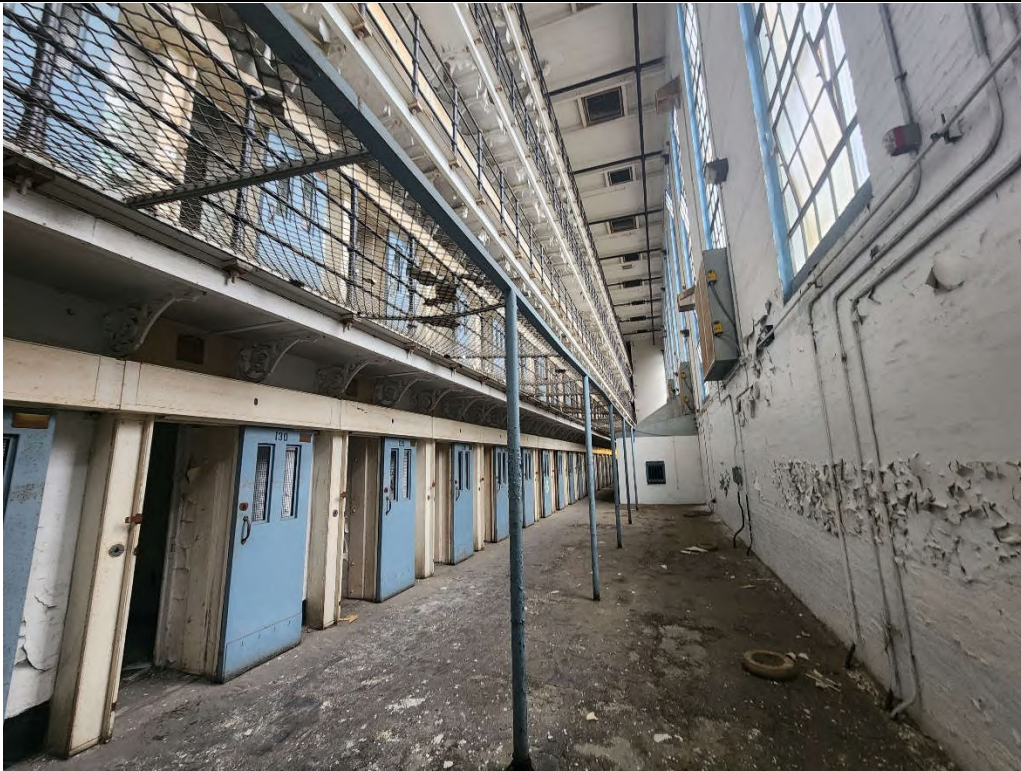
Photograph #2

Example of lead containing paint found throughout all buildings.

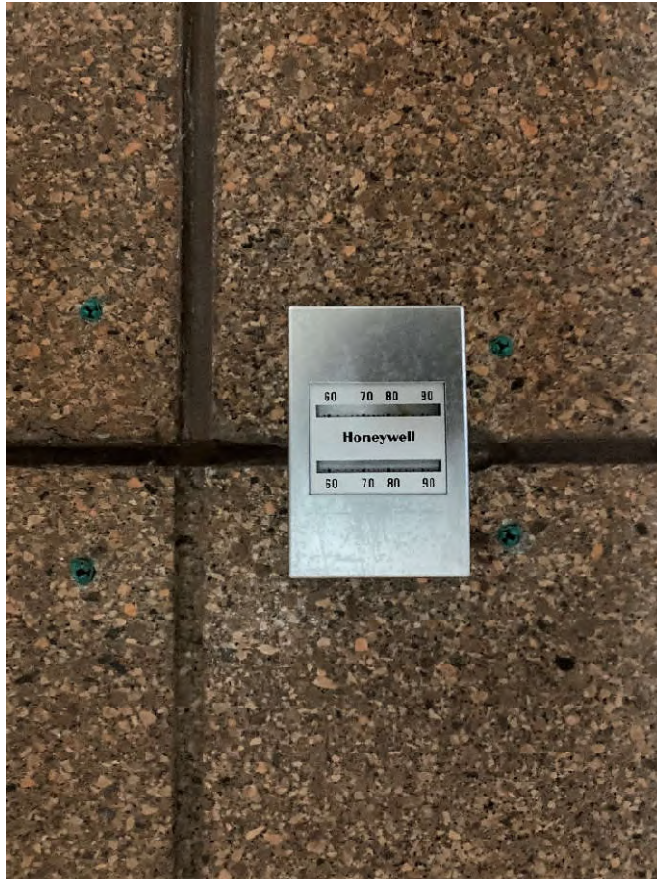
Photograph #4

Example of thermostats found in many of the buildings on site

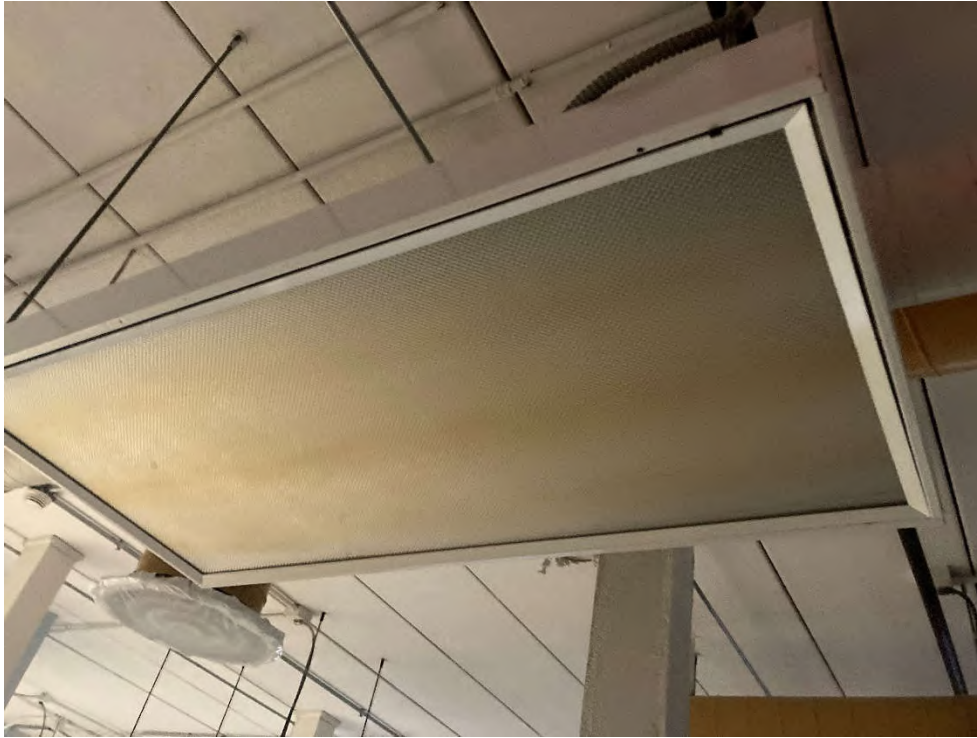
Photograph #5

Example of the lights found throughout all of the buildings on site.
